WEST MAIN STREET

AREA IN NEED OF REHABILITATION STUDY

**Borough of Bound Brook
Somerset County, New Jersey**

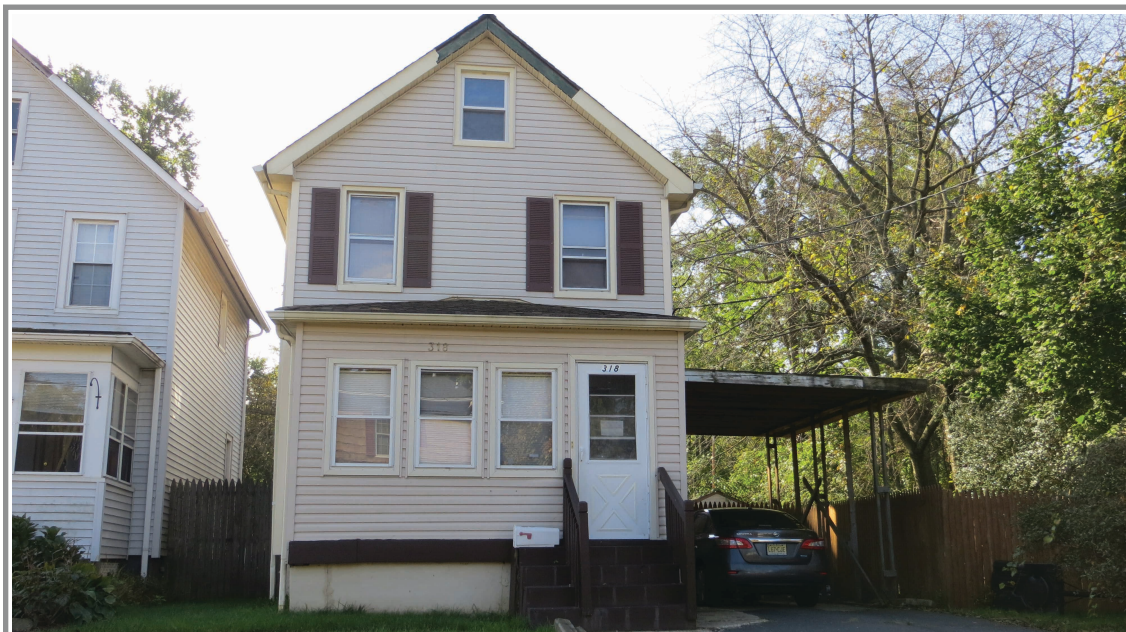
BLOCK 1, LOT 4

Address	318 West Main Street
Acreage	0.13
Acreage in Rehab Area	0.13
Use	2-story frame single-family
Year Built	1900
Habitable Area	1,634 square feet
Condition	Fair
Comments	Requires general upkeep and maintenance to fix loose siding
Code Violations	NA

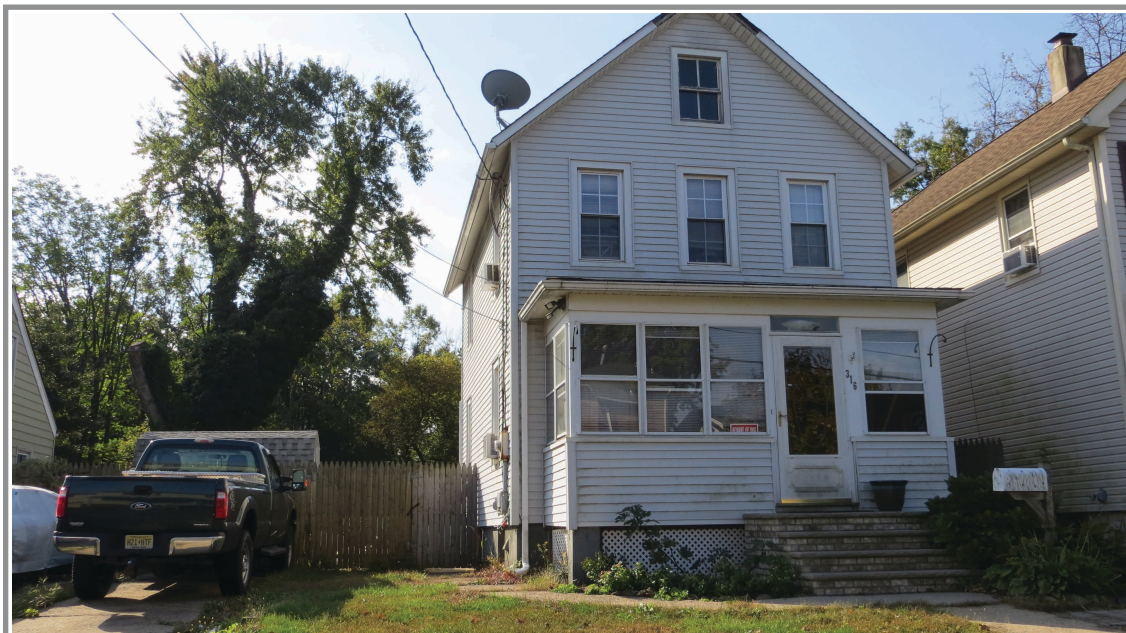
BLOCK 1, LOT 5

Address	316 West Main Street
Acreage	0.12
Acreage in Rehab Area	0.12
Use	2-story frame single-family
Year Built	1909
Habitable Area	988
Condition	Fair
Comments	Requires general upkeep and maintenance to secure and fix loose/damaged siding
Code Violations	NA

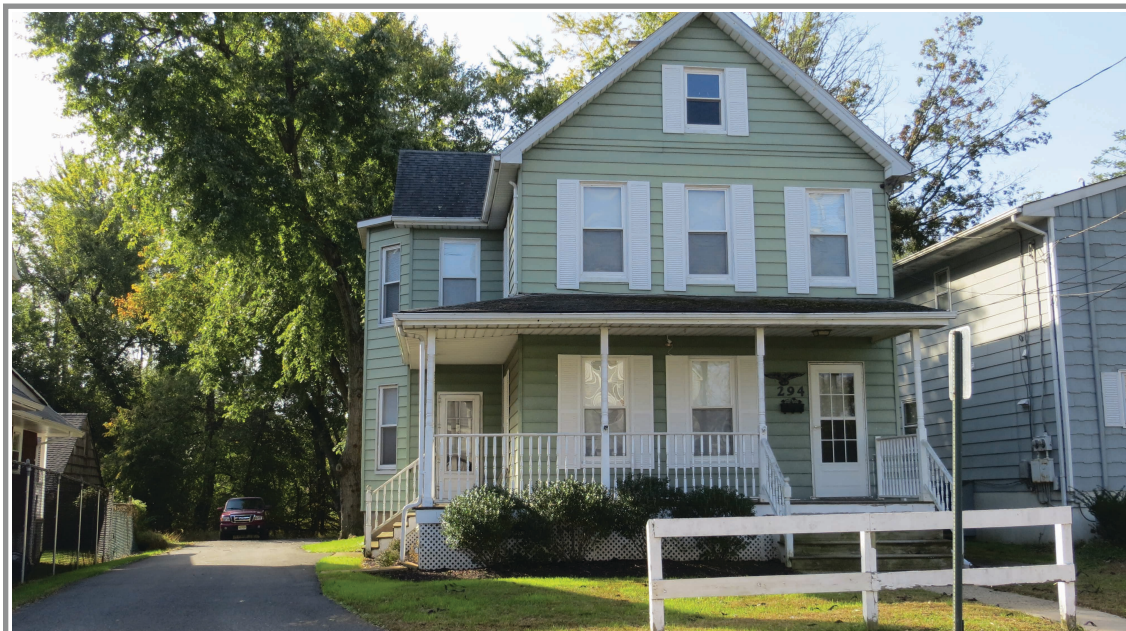
BLOCK 1, LOT 6 (portion of)

Address	294-296 West Main Street
Acreage	6.52
Acreage in Rehab Area	0.12
Use	2-story frame single-family
Year Built	1885/1951
Habitable Area	1,406 square feet
Condition	Fair
Comments	Requires general upkeep; roof has vegetation growing on it and downspout connector is missing
Code Violations	4/30/18 <ul style="list-style-type: none"> • Statute 17-16.17 Doors; • Statute 17-8.2 Unsafe equipment; • Statute 5:10-13.1d Electrical service; • Statute 17-14.3 Sidewalks and driveways; • Statute 5:10-7.7a Railings

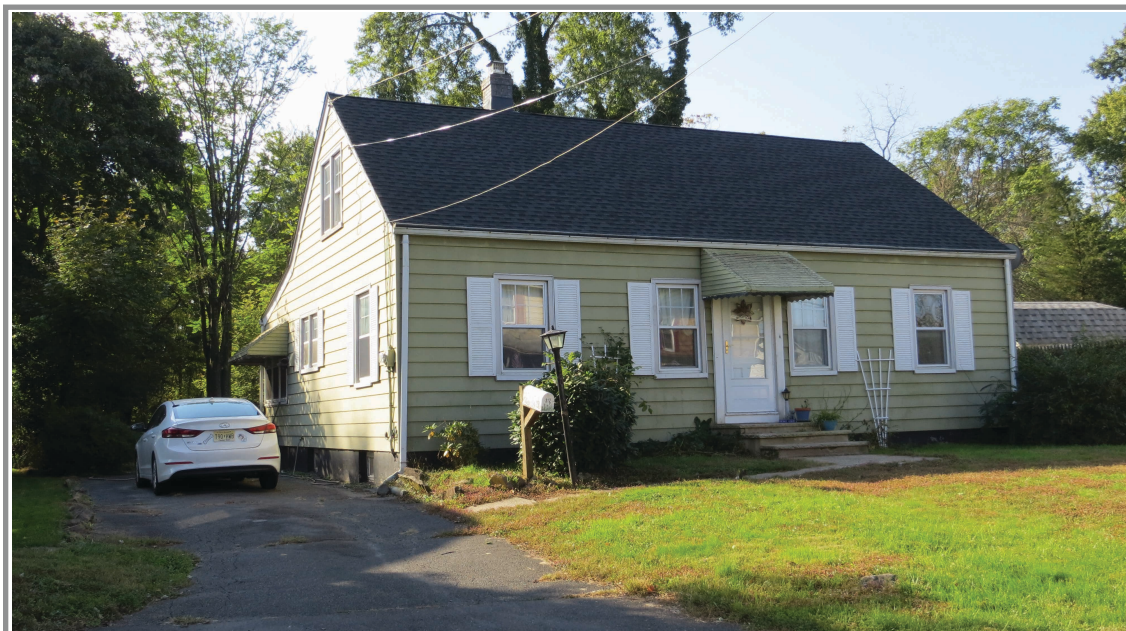
BLOCK 1, LOT 6.01

Address	312 West Main Street
Acreage	0.13
Acreage in Rehab Area	0.13
Use	1-story frame single-family
Year Built	1948
Habitable Area	1,443 square feet
Condition	Fair
Comments	Requires general upkeep
Code Violations	NA

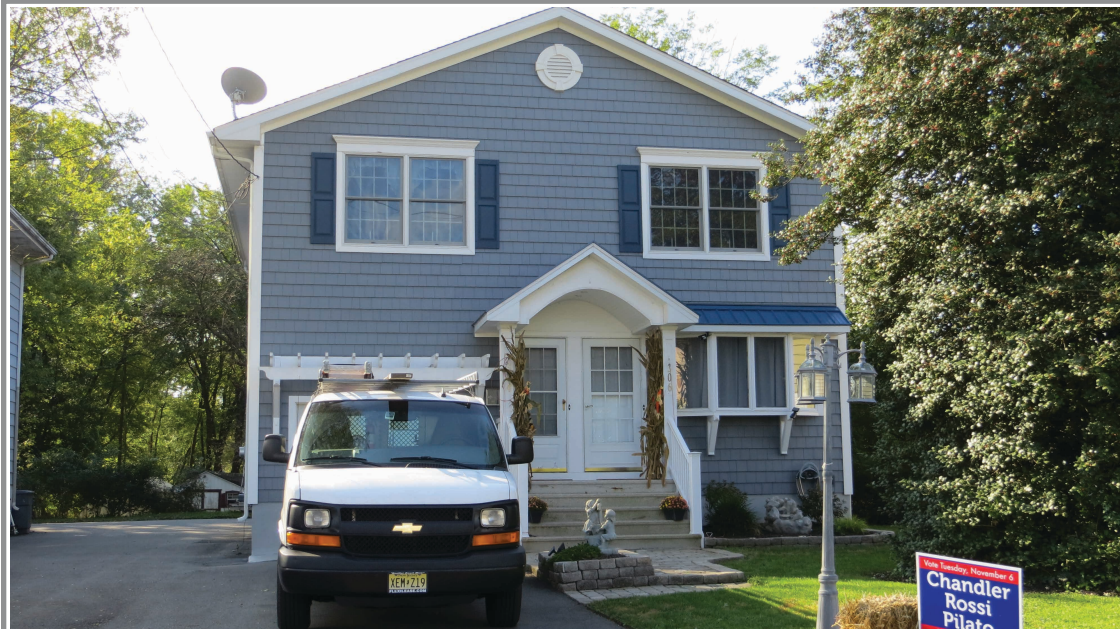
BLOCK 1, LOT 6.02

Address	304-306 West Main Street
Acreage	0.14
Acreage in Rehab Area	0.14
Use	2-story frame two-family 1 car attached garage
Year Built	1980
Habitable Area	2,080 square feet
Condition	Good
Comments	Well maintained property
Code Violations	3/17/18 <ul style="list-style-type: none"> Statute 5:10-1.10e Bureau inspections

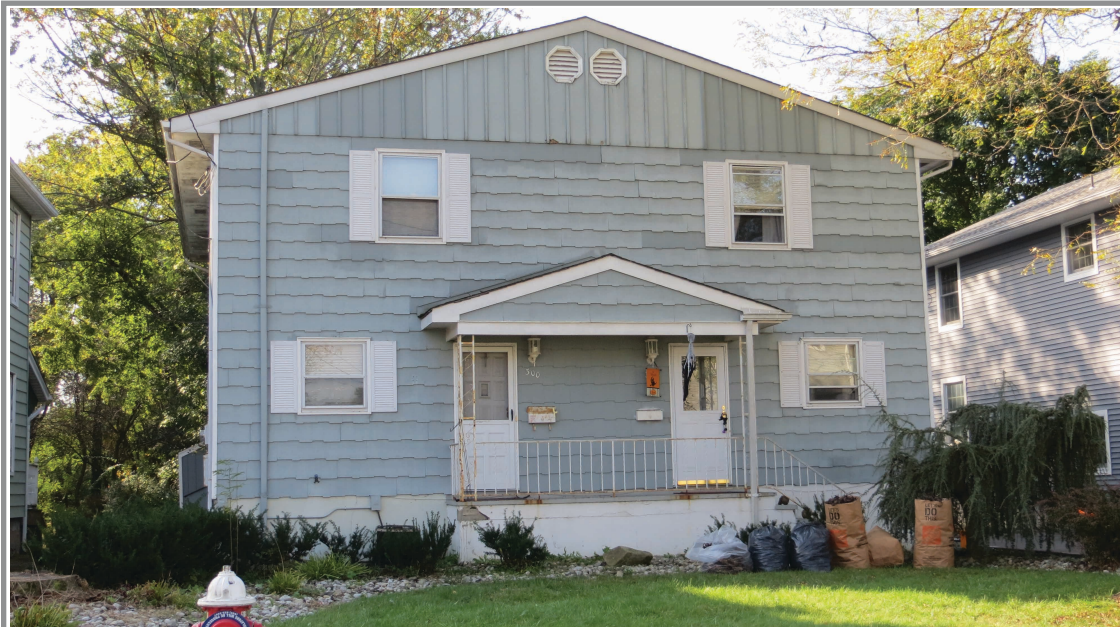
BLOCK 1, LOT 6.03

Address	300-302 West Main Street
Acreage	0.11
Acreage in Rehab Area	0.11
Use	2-story frame two-family
Year Built	1980
Habitable Area	2,592 square feet
Condition	Fair
Comments	Requires general upkeep and maintenance to damaged siding
Code Violations	6/25/18 <ul style="list-style-type: none"> Battery operated smoke detectors; Statute 5:10-28.1a Carbon monoxide alarms; Statute 17-22.12 Single- and Multiple-Station smoke alarms 3/17/18 <ul style="list-style-type: none"> Statute 5:10-1.10e Bureau inspections

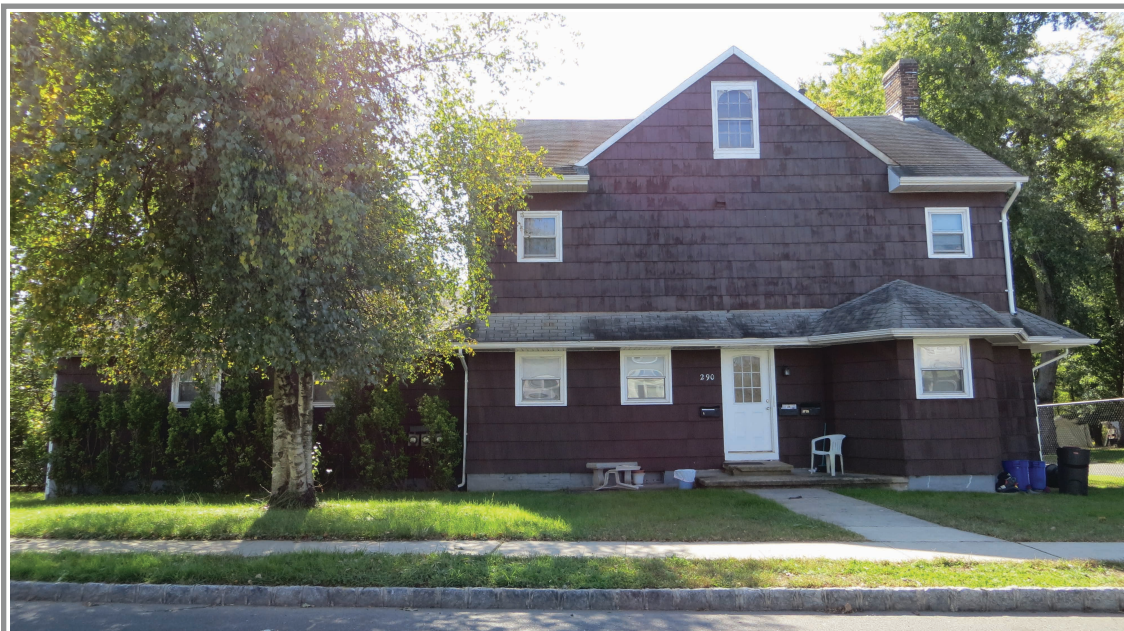
BLOCK 1, LOT 7

Address	290 West Main Street
Acreage	0.54
Acreage in Rehab Area	0.54
Use	2-story frame three-family 3 car detached garage
Year Built	1900
Habitable Area	3,186 square feet
Condition	Fair
Comments	Requires general upkeep
Code Violations	4/7/18 <ul style="list-style-type: none"> • Statute 5:10-7.3a Exterior surfaces; • Statute 17-16.13 Window, skylight, and door frames;
	9/2/17 <ul style="list-style-type: none"> • Statute 17-14 Exterior property

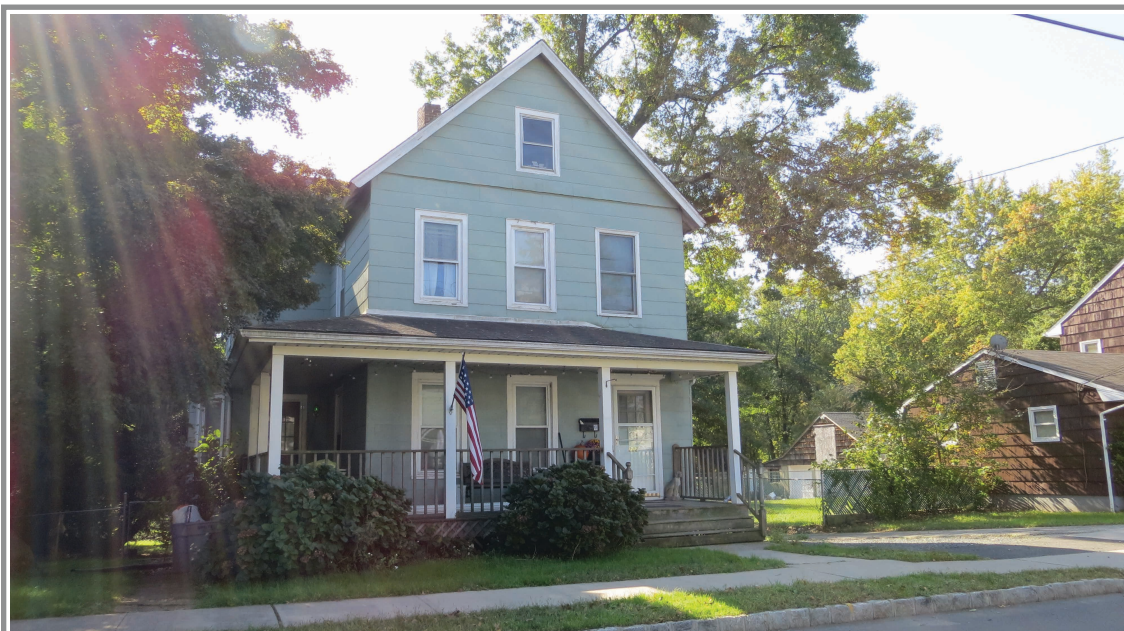
BLOCK 1, LOT 8 (portion of)

Address	282 West Main Street
Acreage	3.08
Acreage in Rehab Area	0.14
Use	2-story frame single-family
Year Built	1900
Habitable Area	1,444 square feet
Condition	Fair
Comments	Requires general upkeep; roof and window inspection
Code Violations	NA

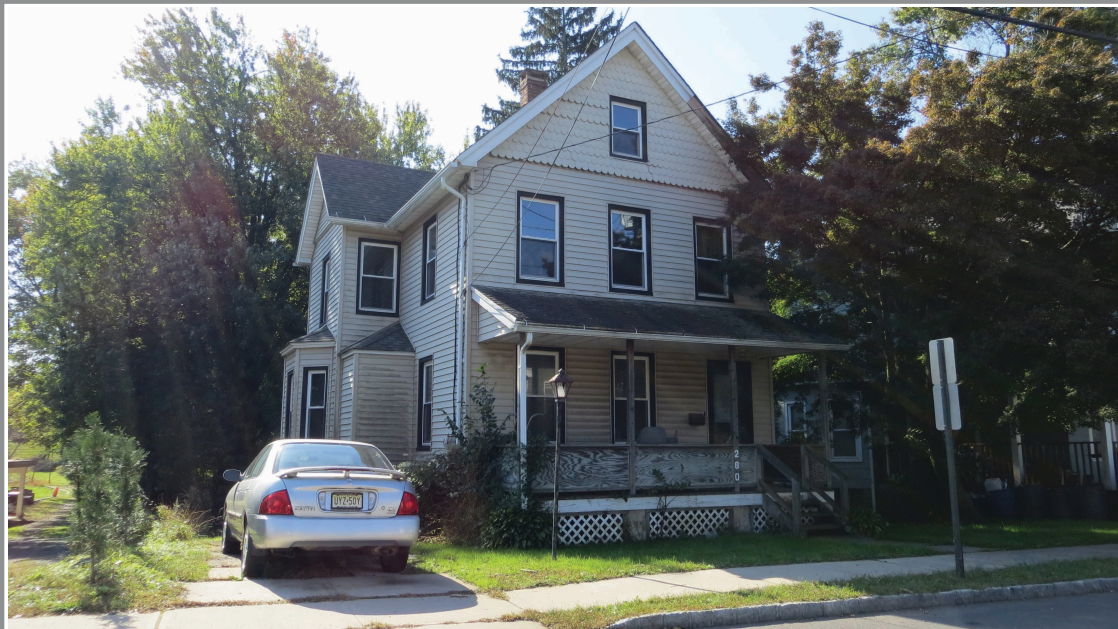
BLOCK 1, LOT 9

Address	280 West Main Street
Acreage	0.1
Acreage in Rehab Area	0.1
Use	2-story frame single-family
Year Built	1908
Habitable Area	1,226 square feet
Condition	Fair
Comments	Requires general upkeep; requires inspection of roof and repair of siding
Code Violations	NA

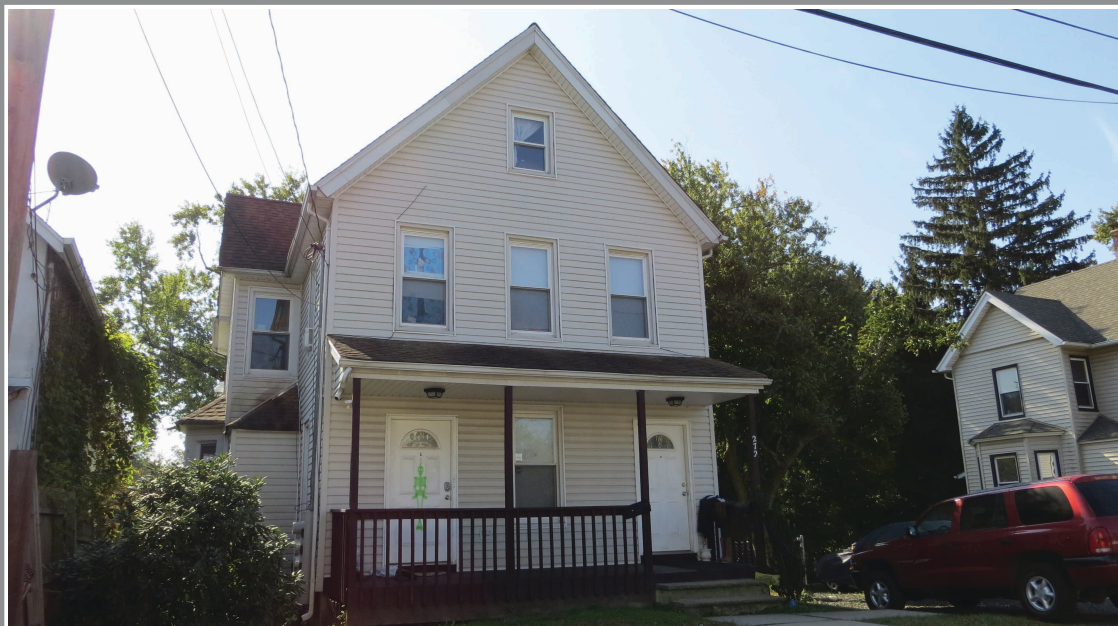
BLOCK 1, LOT 10 (portion of)

Address	272 West Main Street
Acreage	4.22
Acreage in Rehab Area	0.19
Use	2-story frame two-family Garage/structure
Year Built	1907/1948
Habitable Area	2,382 square feet
Condition	Fair
Comments	Requires general upkeep; requires repair to missing downspout connector
Code Violations	8/11/18 <ul style="list-style-type: none"> • Statute 17-14.4 Weeds 3/12/18 <ul style="list-style-type: none"> • Statute 5:10-1.10e Bureau inspections

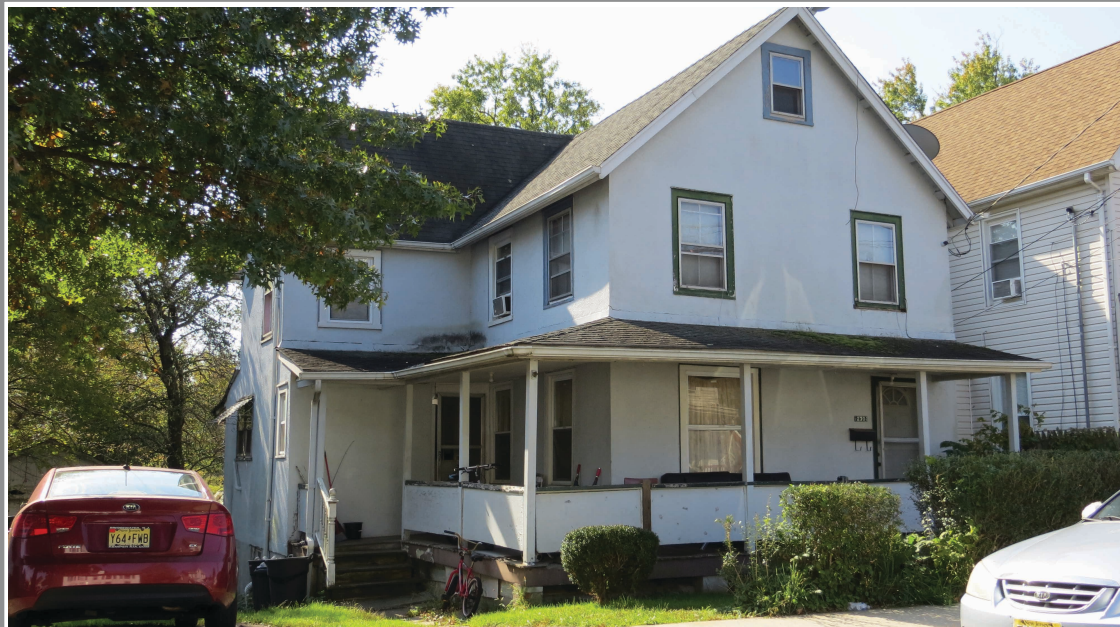
BLOCK 1, LOT 11

Address	270 West Main Street
Acreage	0.14
Acreage in Rehab Area	0.14
Use	2-story stucco single-family 1 car detached garage
Year Built	1927
Habitable Area	1,414 square feet
Condition	Poor
Comments	Requires general property upkeep and maintenance for windows and roof
Code Violations	NA

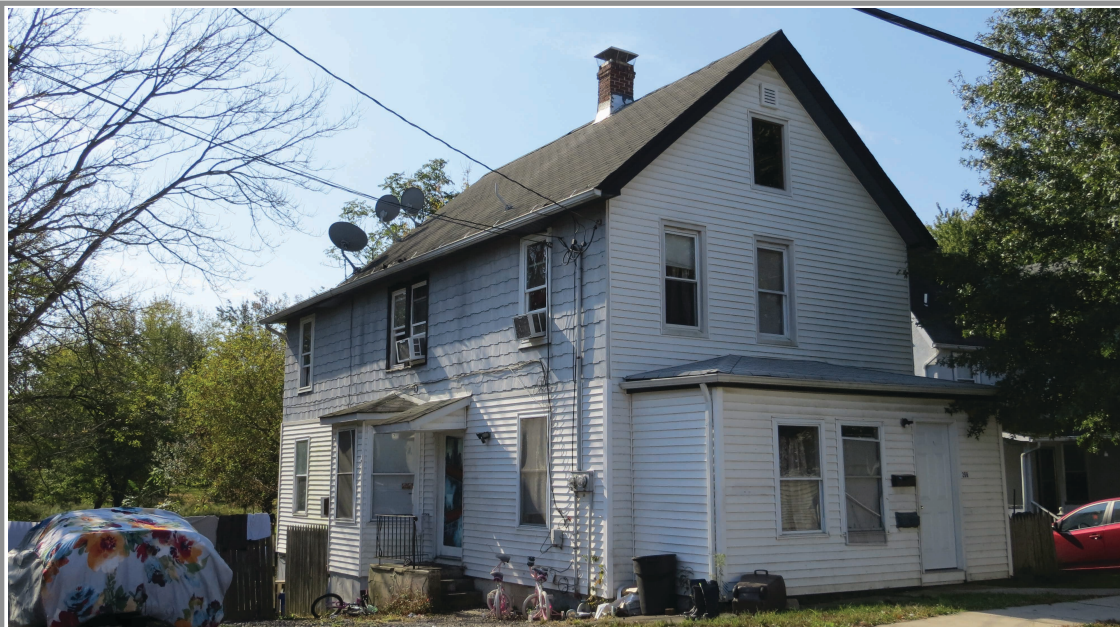
BLOCK 1, LOT 12

Address	266 West Main Street
Acreage	0.14
Acreage in Rehab Area	0.14
Use	2-story frame two-family
Year Built	1909
Habitable Area	1,744 square feet
Condition	Poor
Comments	Requires upkeep; maintenance to windows/screens/doors

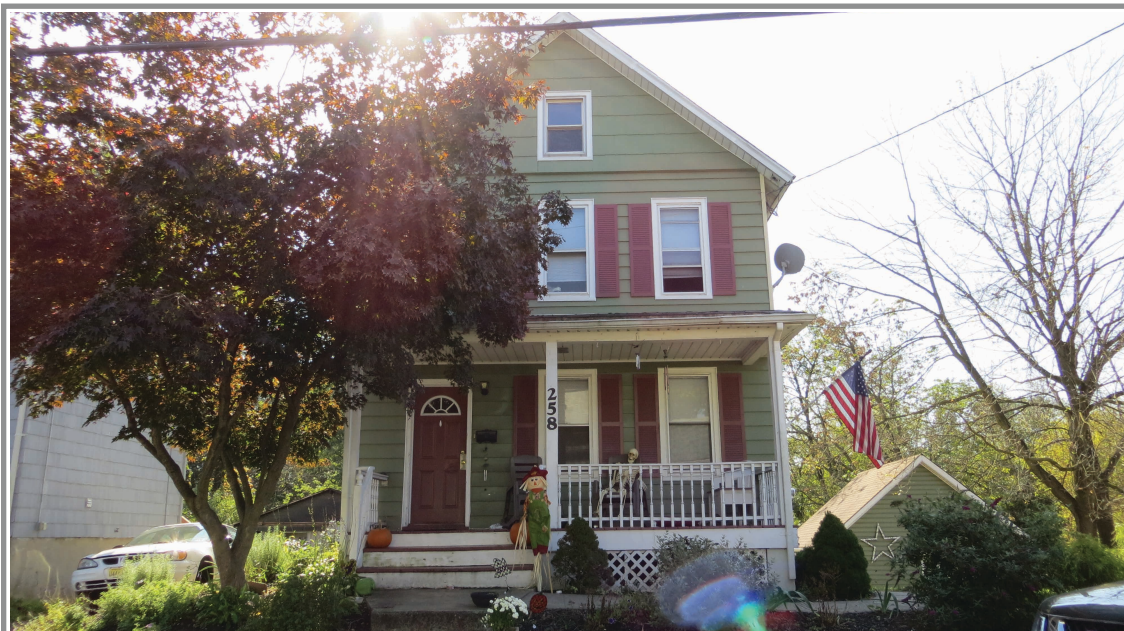
BLOCK 1, LOT 13

Address	258 West Main Street
Acreage	0.18
Acreage in Rehab Area	0.18
Use	2-story frame single-family, 1 car detached garage
Year Built	1910
Habitable Area	1,260 square feet
Condition	Good
Comments	NA
Code Violations	NA

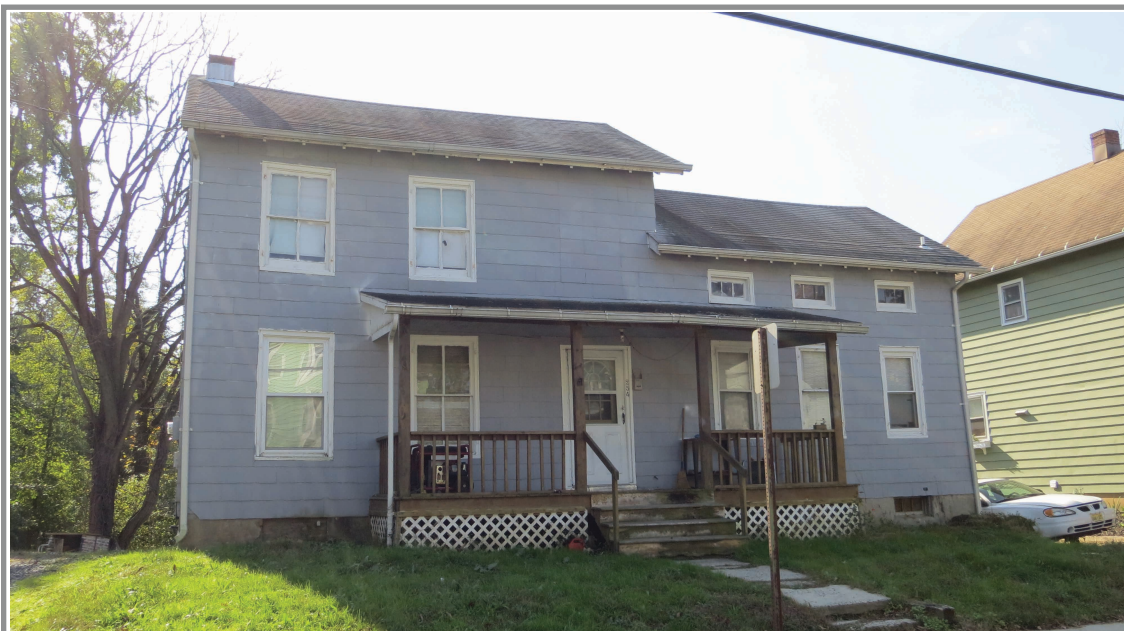
BLOCK 1, LOT 14

Address	254 West Main Street
Acreage	0.17
Acreage in Rehab Area	0.17
Use	2-story frame single-family 2 car detached garage
Year Built	1917
Habitable Area	1,368 square feet
Condition	Poor
Comments	Requires general upkeep and inspection of structure; requires maintenance for windows and roof
Code Violations	6/23/18 <ul style="list-style-type: none"> • Statute 17-14.9 Motor vehicles

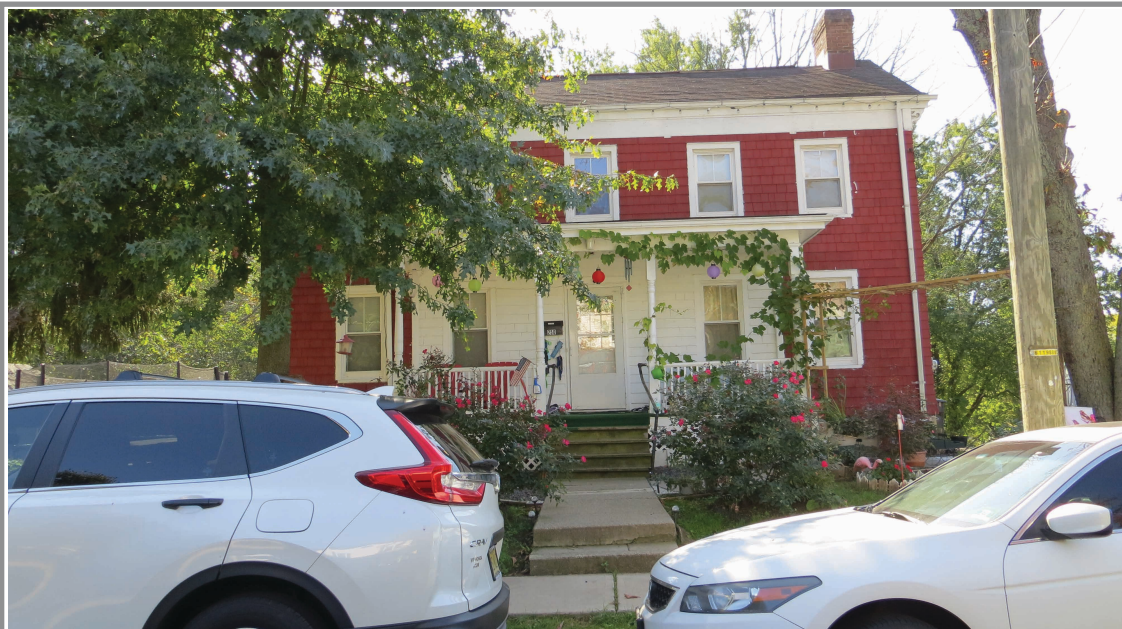
BLOCK 1, LOT 15 (portion of)

Address	250 West Main Street
Acreage	4.04
Acreage in Rehab Area	0.4
Use	2-story frame single-family
Year Built	1859
Habitable Area	1,716 square feet
Condition	Fair
Comments	Requires repair to siding on side of structure
Code Violations	12/9/17 <ul style="list-style-type: none">Statute 17-16.1 General exterior structure

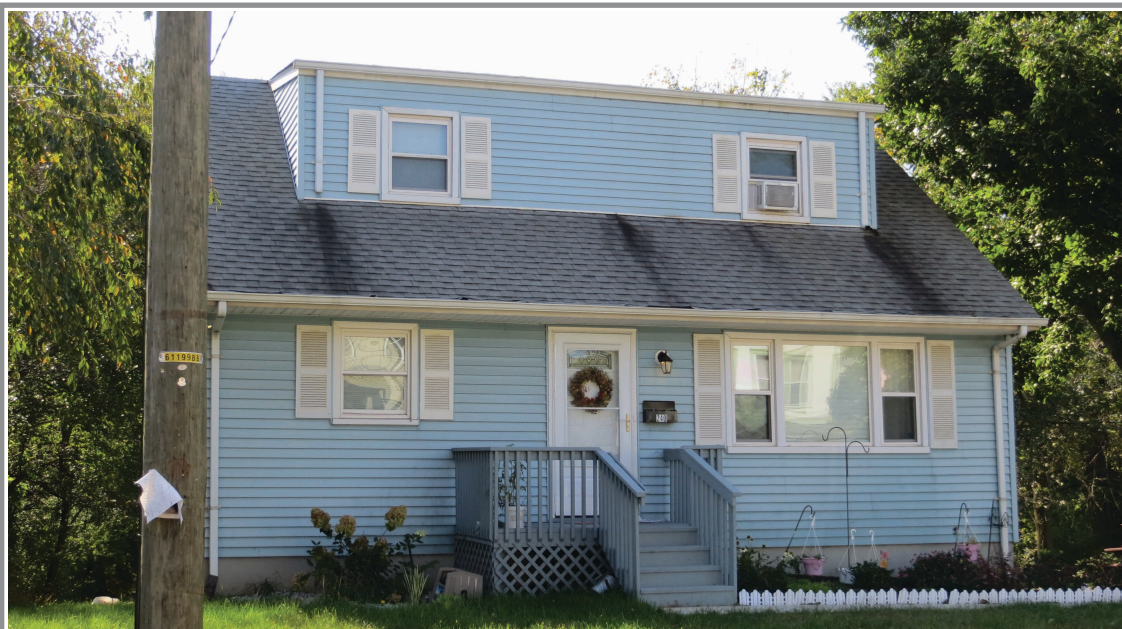
BLOCK 1, LOT 16

Address	240 West Main Street
Acreage	0.25
Acreage in Rehab Area	0.25
Use	1.5-story frame single-family 1 car detached garage
Year Built	1962/1975
Habitable Area	1,116 square feet
Condition	Good
Comments	NA
Code Violations	NA

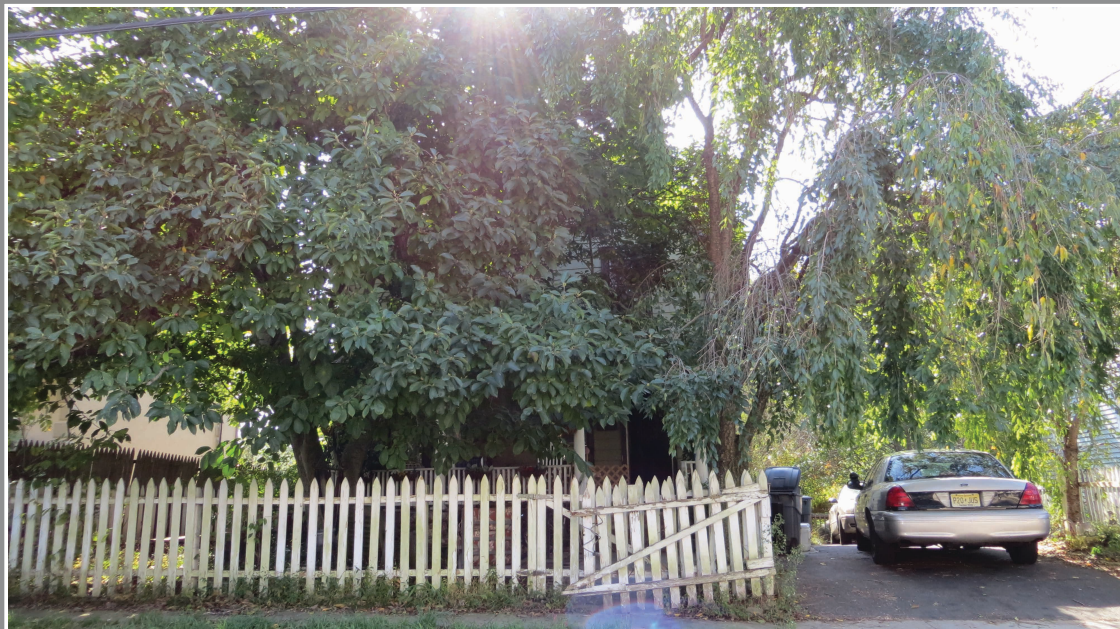
BLOCK 1, LOT 17

Address	238 West Main Street
Acreage	0.19
Acreage in Rehab Area	0.19
Use	2-story frame single-family
Year Built	1933
Habitable Area	2,055 square feet
Condition	Good
Comments	Requires general property upkeep; fix gates so they do not interfere with sidewalk passage or front entry to property
Code Violations	NA

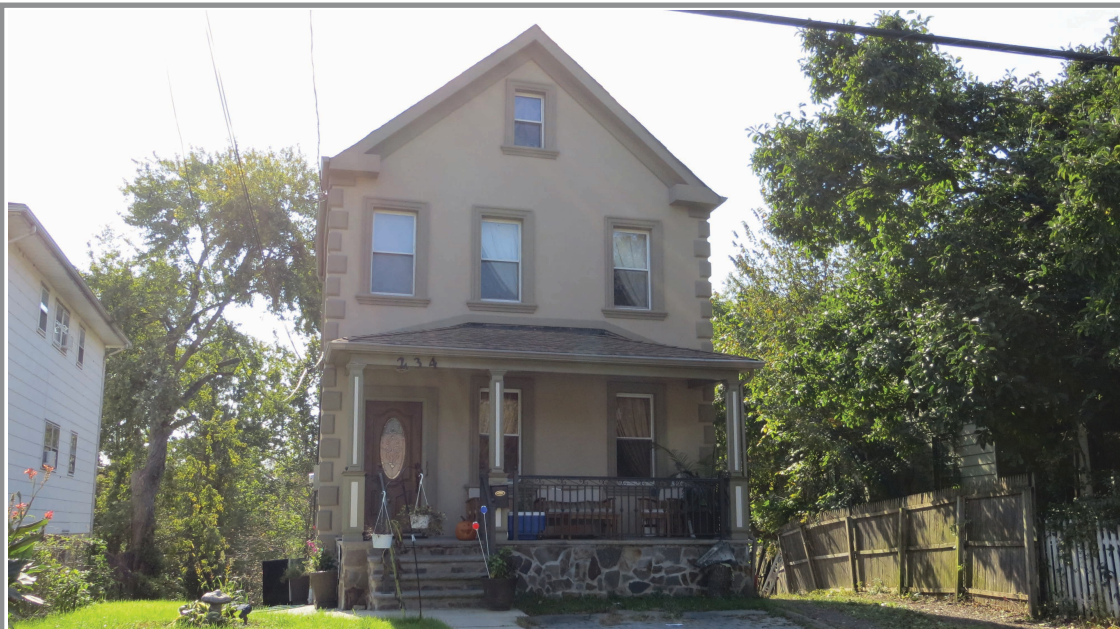
BLOCK 1, LOT 18

Address	234 West Main Street
Acreage	0.14
Acreage in Rehab Area	0.14
Use	2.5-story stucco single-family
Year Built	1900/1958
Habitable Area	966 square feet
Condition	Good
Comments	NA
Code Violations	NA

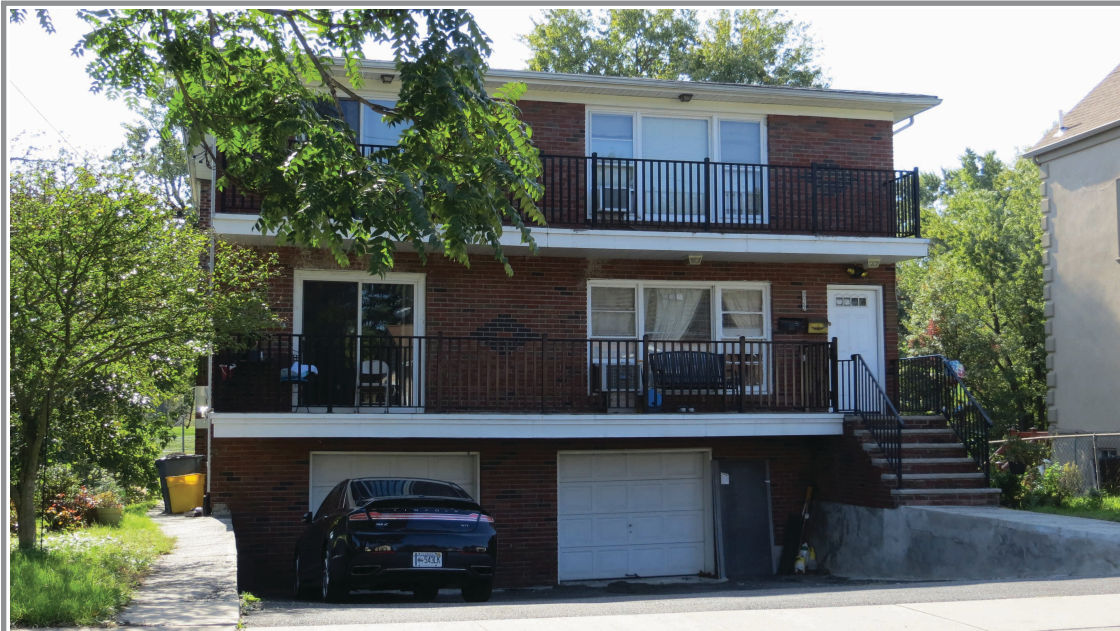
BLOCK 1, LOT 18.01

Address	232 West Main Street
Acreage	0.16
Acreage in Rehab Area	0.16
Use	3-story (2 over a 2 car attached garage) brick two-family
Year Built	1976
Habitable Area	3,080 square feet
Condition	Good
Comments	NA
Code Violations	NA

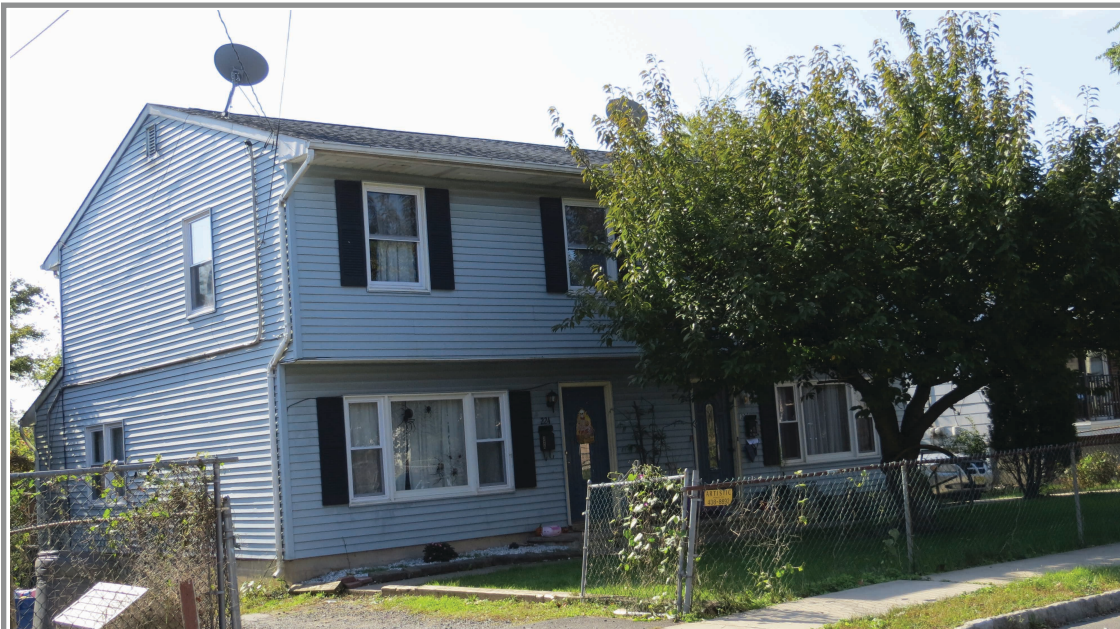
BLOCK 1, LOT 19

Address	224-226 West Main Street
Acreage	0.3
Acreage in Rehab Area	0.3
Use	2-story frame two-family
Year Built	1986
Habitable Area	2,798 square feet
Condition	Fair
Comments	Requires general upkeep and maintenance, e.g. secure soffit
Code Violations	3/12/18 & 2/28/18 <ul style="list-style-type: none">Statute 17-20.1 Accumulation of rubbish, garbage, trash and debris 2/27/18 <ul style="list-style-type: none">Statute 17-20.4 Appliances, furniture, mattresses, discarded items

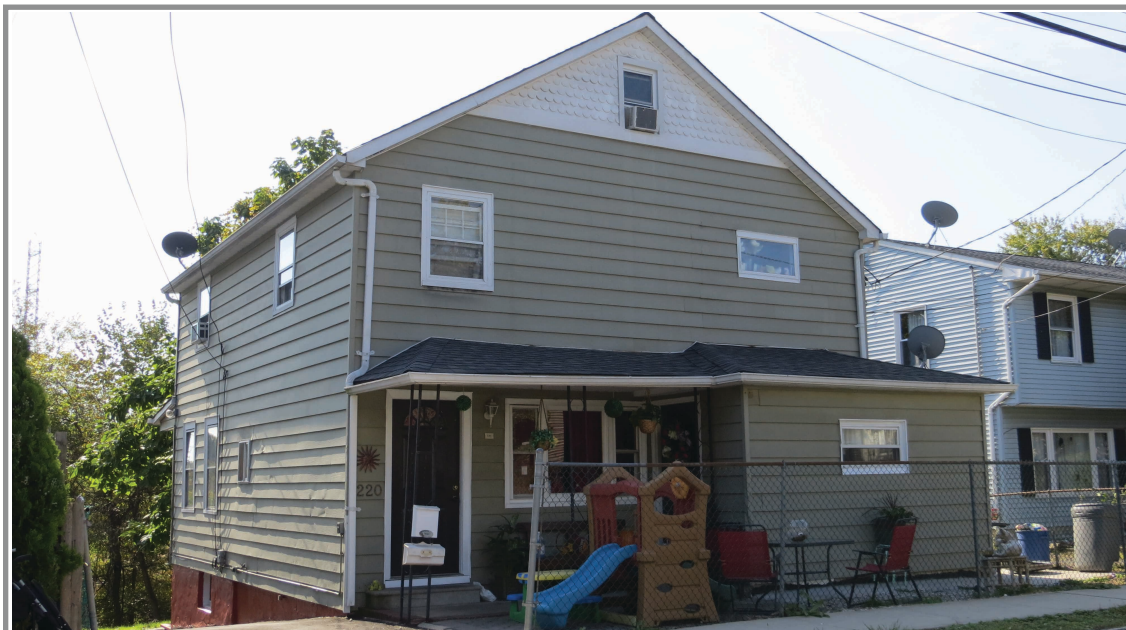
BLOCK 1, LOT 20

Address	220 West Main Street
Acreage	0.12
Acreage in Rehab Area	0.12
Use	2.5-story frame single-family
Year Built	1859
Habitable Area	1,843 square feet
Condition	Good
Comments	NA
Code Violations	3/12/18 <ul style="list-style-type: none">• Statute 17-26.7 Inspections;• Statute 17-20.1 Accumulation of Rubbish, Garbage, Trash and Debris 2/10/18 <ul style="list-style-type: none">• Statute 17-20.1 Accumulation of Rubbish, Garbage, Trash and Debris 7/1/17 <ul style="list-style-type: none">• Weeds

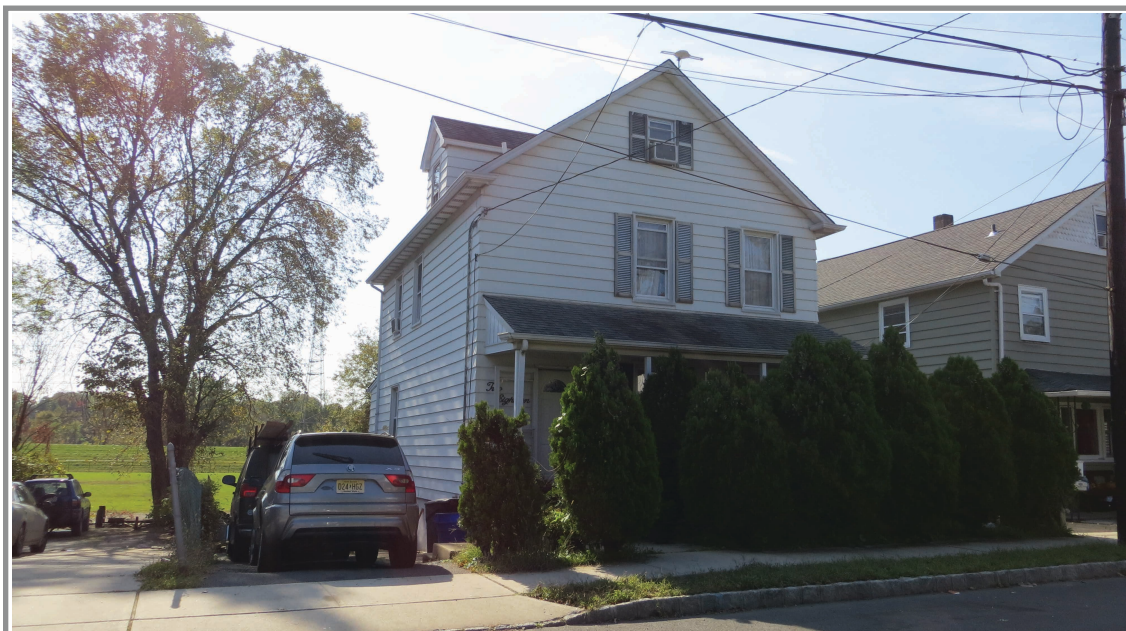
BLOCK 1, LOT 21

Address	218 West Main Street
Acreage	0.11
Acreage in Rehab Area	0.11
Use	2.5-story frame single-family
Year Built	1913
Habitable Area	1,232 square feet
Condition	Fair
Comments	Requires general upkeep and repairs to window screens and door
Code Violations	NA

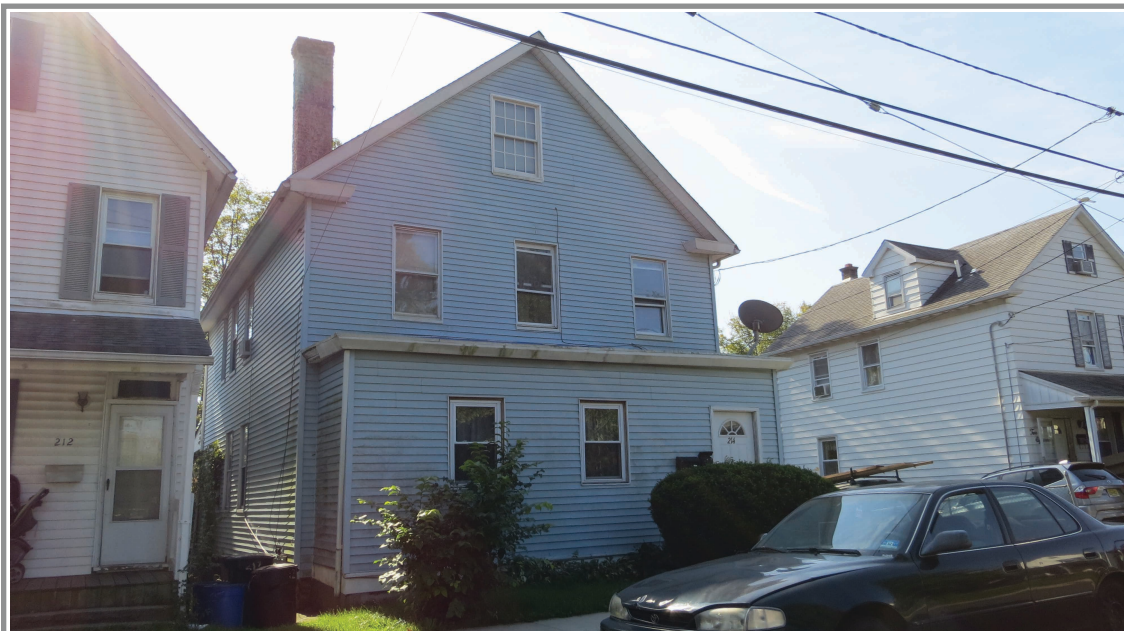
BLOCK 1, LOT 22

Address	214 West Main Street
Acreage	0.13
Acreage in Rehab Area	0.13
Use	2.5-story frame single-family
Year Built	1885
Habitable Area	2,032 square feet
Condition	Fair
Comments	Requires general upkeep; requires maintenance to siding and windows
Code Violations	3/12/18 <ul style="list-style-type: none"> • Statute 17-22.20 Smoke detection system; • Statute 5:10-1.10d2 Bureau inspections

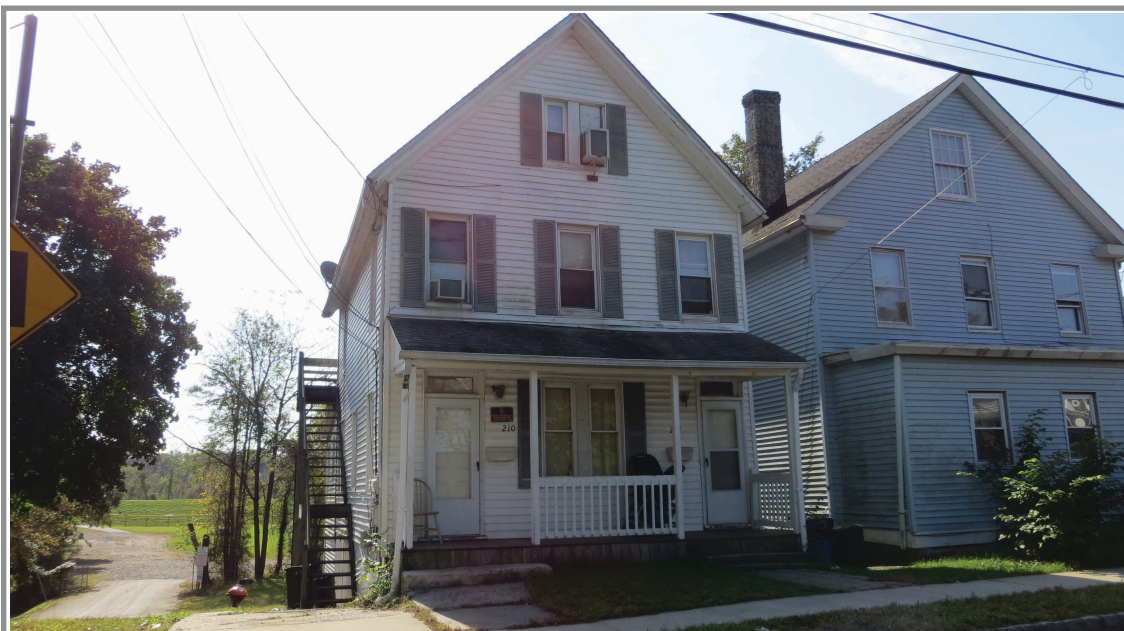
BLOCK 1, LOT 23

Address	210 West Main Street
Acreage	0.1
Acreage in Rehab Area	0.1
Use	2.5-story frame two-family
Year Built	1875
Habitable Area	1,540 square feet
Condition	Fair
Comments	Requires general upkeep
Code Violations	4/2/18 <ul style="list-style-type: none"> • Statute 5:10-7.3a Exterior surfaces; • Statute 17-22.12 Single and multi-station smoke alarms; • Statute 17-16.16 Insect screens; • Statute 5:10-28.1a Carbon monoxide alarms; • Statute 17-17.4 Interior surfaces
	9/1/17 <ul style="list-style-type: none"> • Statute 17-20.7 Containers

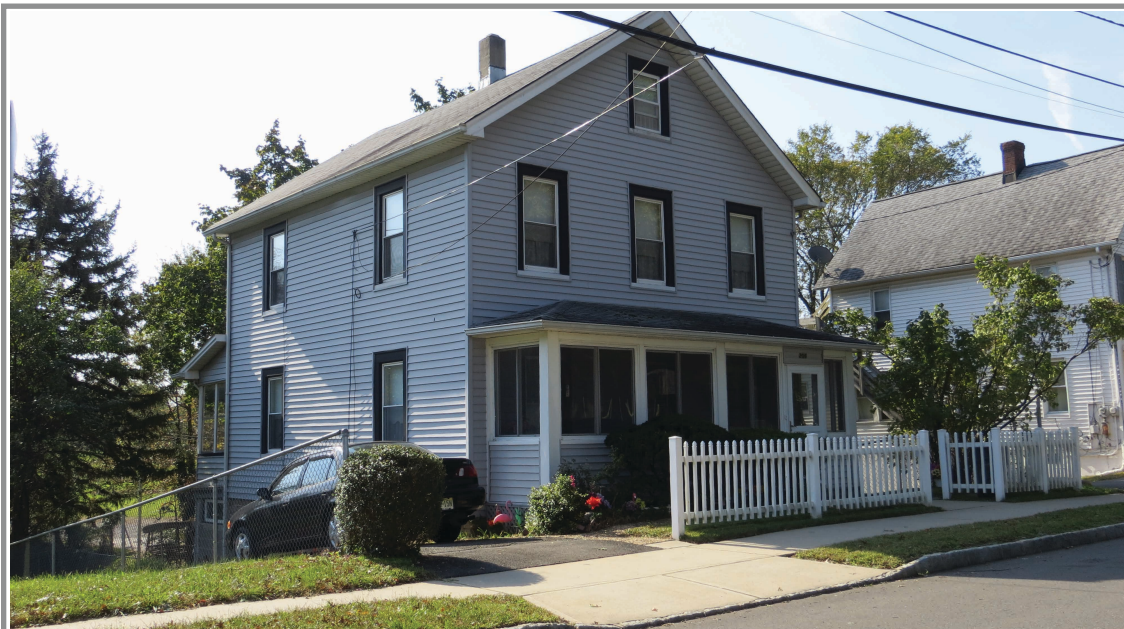
BLOCK 1, LOT 25

Address	206 West Main Street
Acreage	0.14
Acreage in Rehab Area	0.14
Use	2.5-story frame single-family
Year Built	1907
Habitable Area	1,432 square feet
Condition	Good
Comments	NA
Code Violations	NA

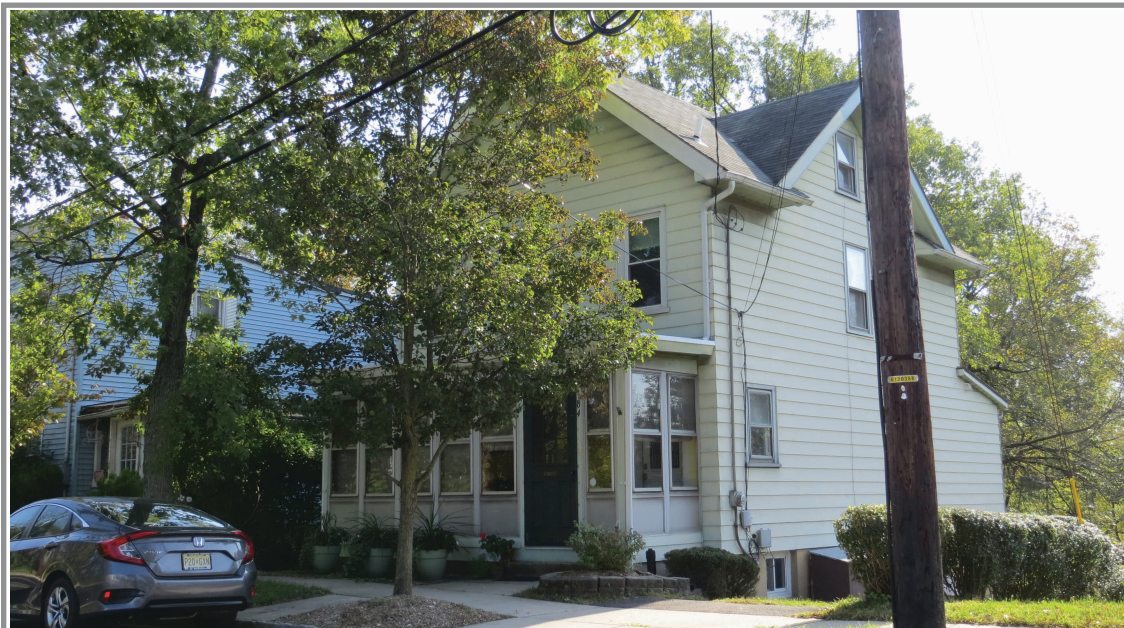
BLOCK 1, LOT 27

Address	184 West Main Street
Acreage	0.18
Acreage in Rehab Area	0.18
Use	2.5-story frame single-family
Year Built	1912
Habitable Area	1,310 square feet
Condition	Good
Comments	NA
Code Violations	NA

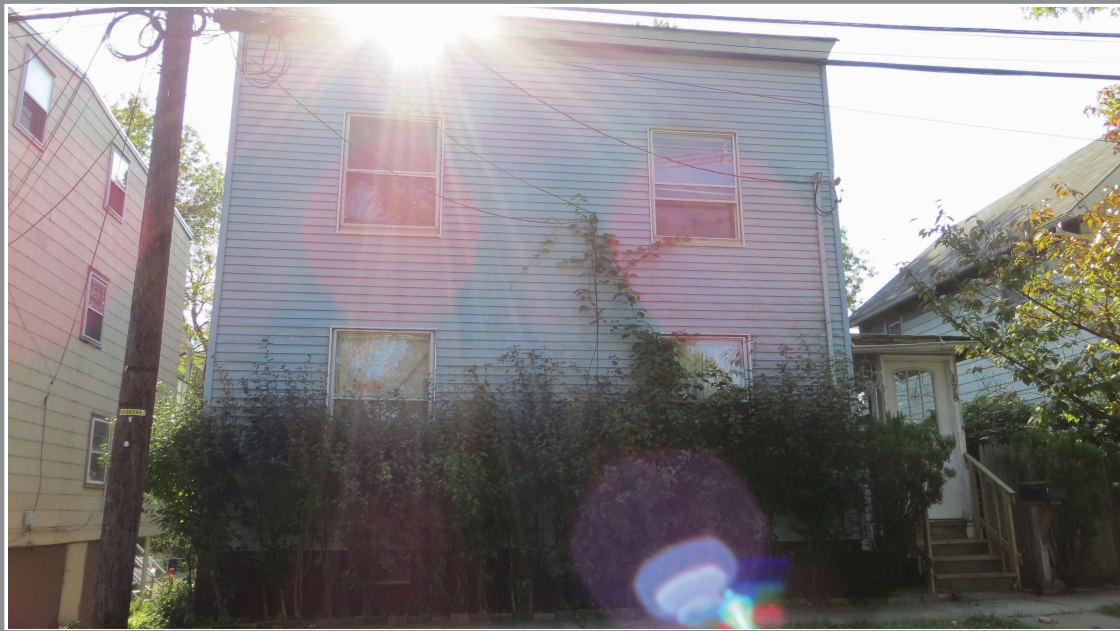
BLOCK 1, LOT 28

Address	178 West Main Street
Acreage	0.21
Acreage in Rehab Area	0.21
Use	2-story frame single-family
Year Built	1859
Habitable Area	1,550 square feet
Condition	Fair
Comments	Requires general upkeep; vegetation requires pruning; gutter by front door needs to be secured
Code Violations	NA

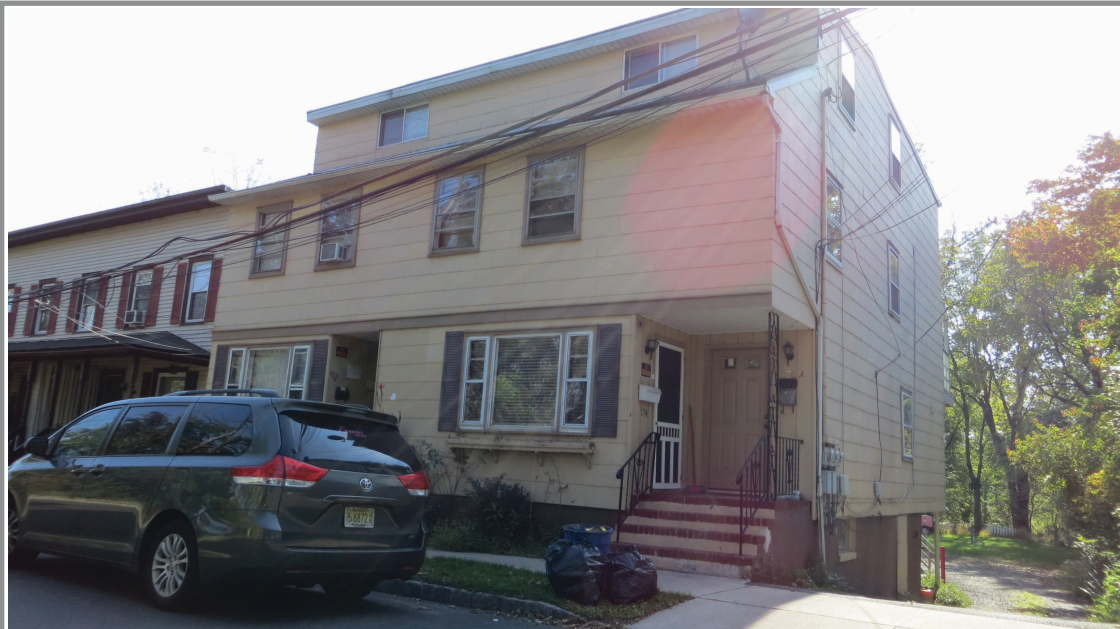
BLOCK 1, LOT 29

Address	172-174 West Main Street
Acreage	0.3
Acreage in Rehab Area	0.3
Use	3-story frame three-family
Year Built	1895
Habitable Area	3,877 square feet
Condition	Fair
Comments	Requires general upkeep; requires yard maintenance and removal of litter
Code Violations	3/17/18 <ul style="list-style-type: none">• Statute 5:10-1.10e Bureau inspections
