WEST MAIN STREET

AREA IN NEED OF REHABILITATION STUDY

**Borough of Bound Brook
Somerset County, New Jersey**

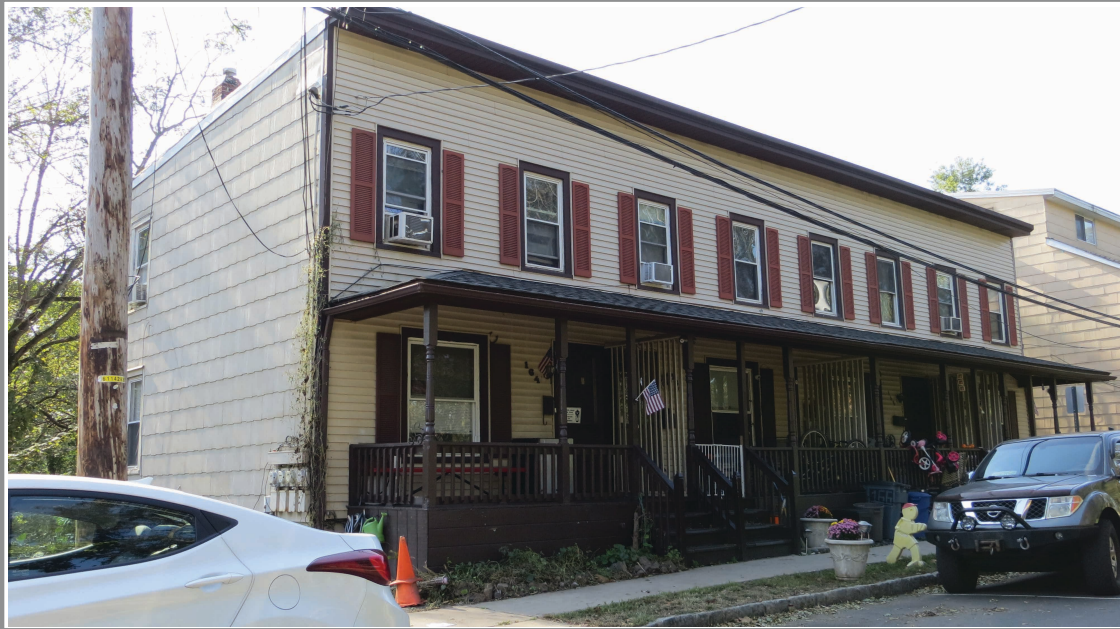
BLOCK 1, LOT 30

Address	164-170 West Main Street
Acreage	0.12
Acreage in Rehab Area	0.12
Use	2-story frame four-family
Year Built	1900
Habitable Area	4,384 square feet
Condition	Good
Comments	Requires general upkeep
Code Violations	NA

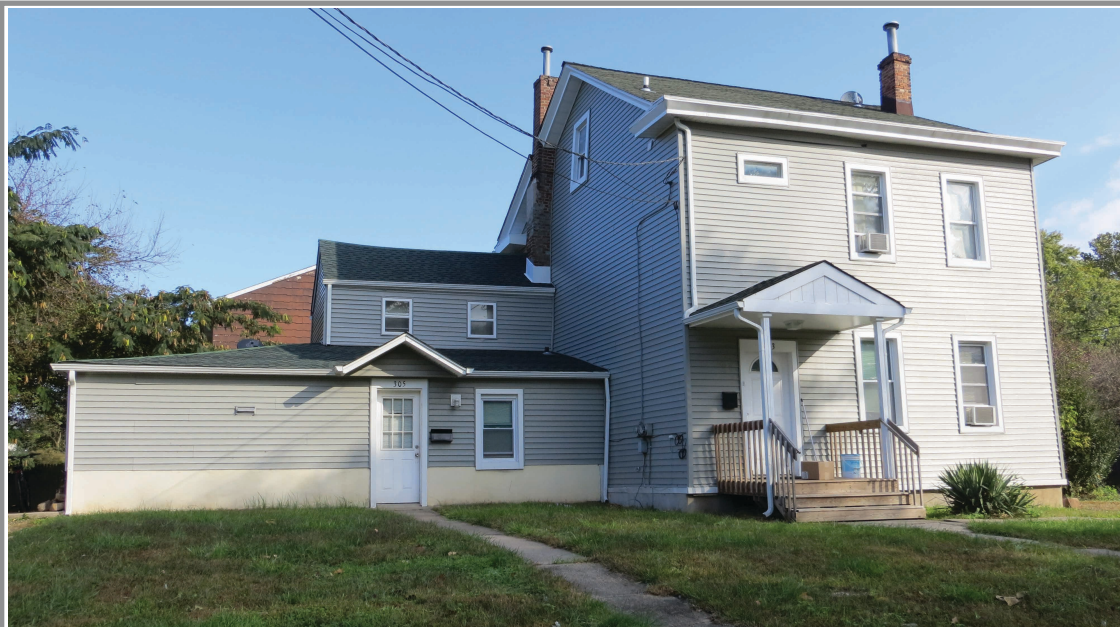
BLOCK 3, LOT 7

Address	303-305 West Main Street
Acreage	0.15
Acreage in Rehab Area	0.15
Use	2.5-story frame two-family
Year Built	1900
Habitable Area	4,384 square feet
Condition	Good
Comments	NA
Code Violations	5/10/18 <ul style="list-style-type: none">• Statute 17-14.4 Weeds 3/12/18 <ul style="list-style-type: none">• Statute 5:10-1.10e Bureau inspections 9/2/17 <ul style="list-style-type: none">• Statute 17-14 Exterior property

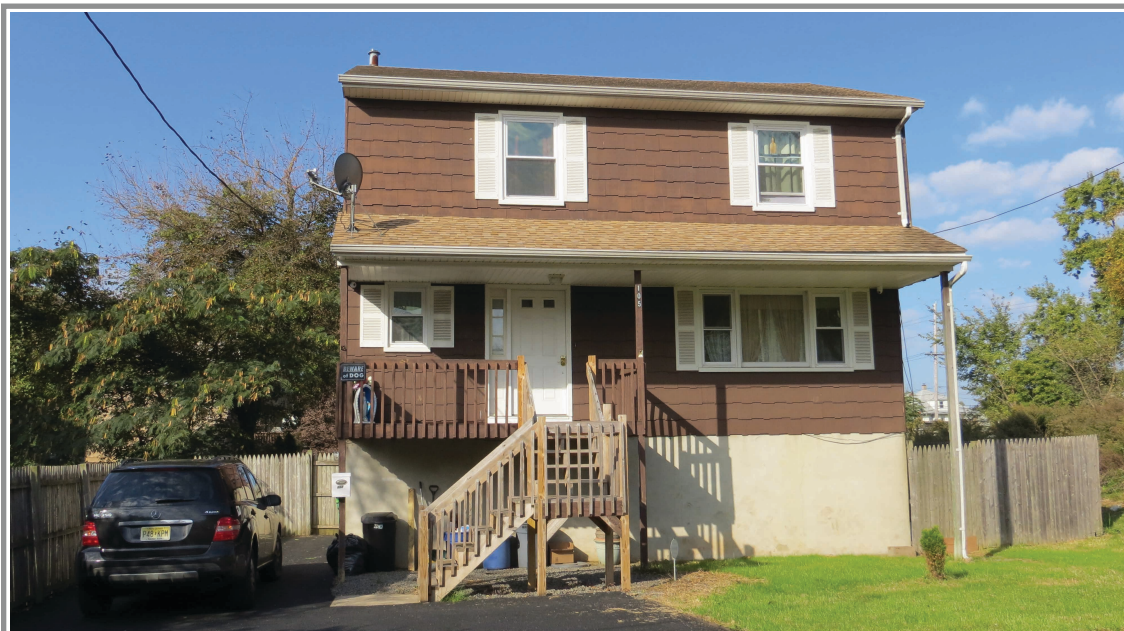
BLOCK 3, LOT 7.01

Address	105 La Monte Avenue
Acreage	0.12
Acreage in Rehab Area	0.12
Use	2-story frame single-family
Year Built	1992
Habitable Area	1,440 square feet
Condition	Good
Comments	Well maintained
Code Violations	NA

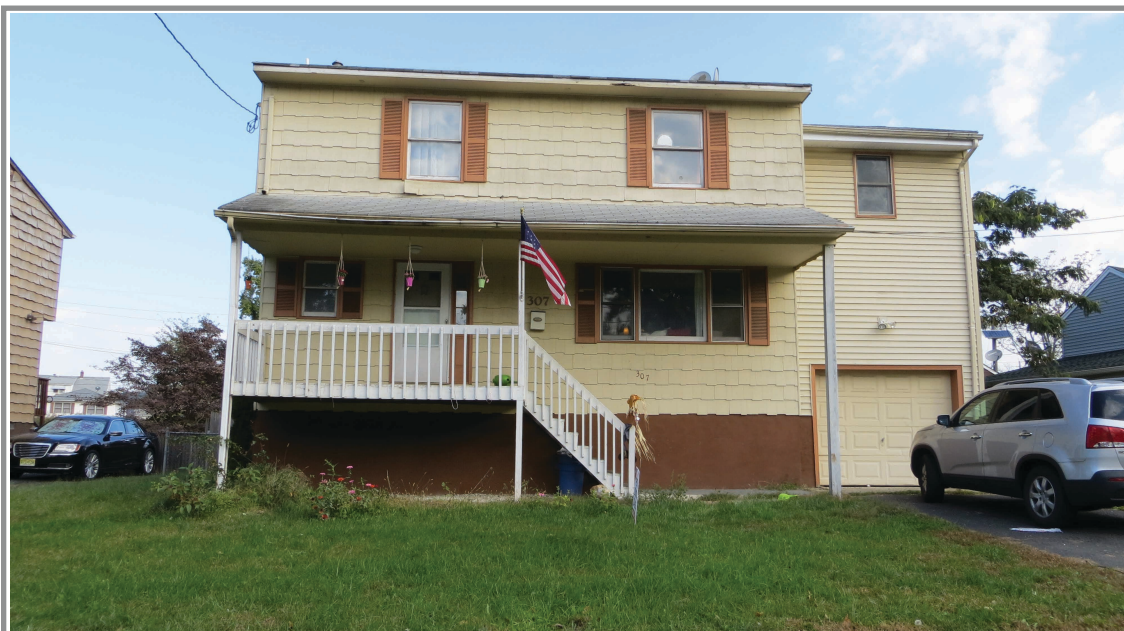
BLOCK 3, LOT 7.02

Address	307 West Main Street
Acreage	0.14
Acreage in Rehab Area	0.14
Use	2-story frame single-family 1 car attached garage
Year Built	1988
Habitable Area	1,500 square feet
Condition	Fair
Comments	Requires general upkeep and maintenance, e.g. fix low hanging gutters, reattach siding, fix windows
Code Violations	NA

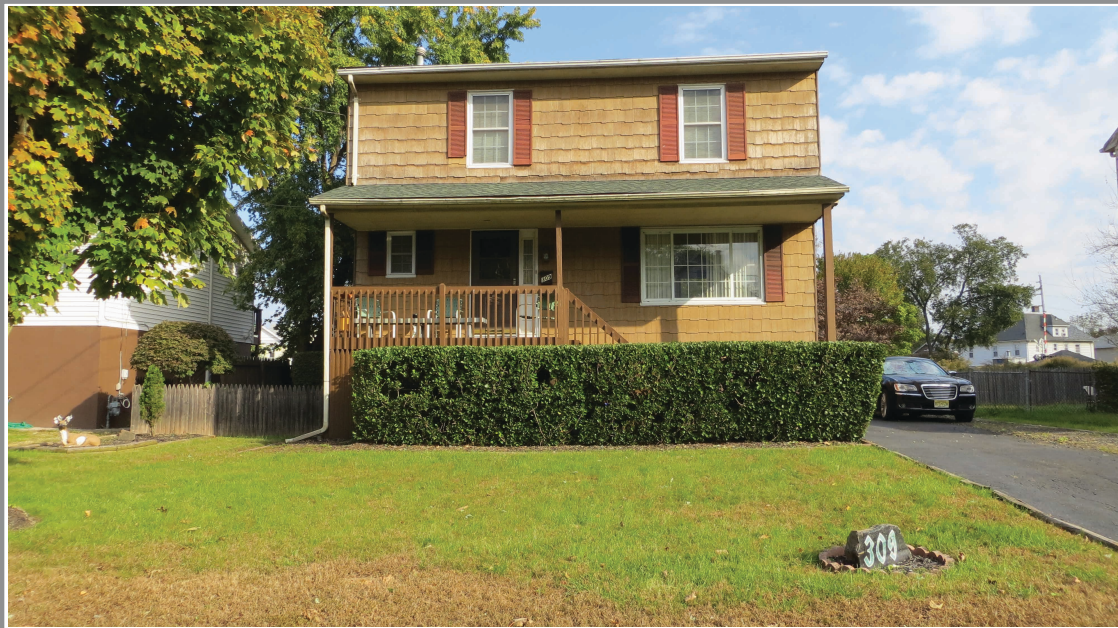
BLOCK 3, LOT 7.03

Address	309 West Main Street
Acreage	0.13
Acreage in Rehab Area	0.13
Use	2-story frame single-family
Year Built	1988
Habitable Area	1,764 square feet
Condition	Good
Comments	Well maintained
Code Violations	NA

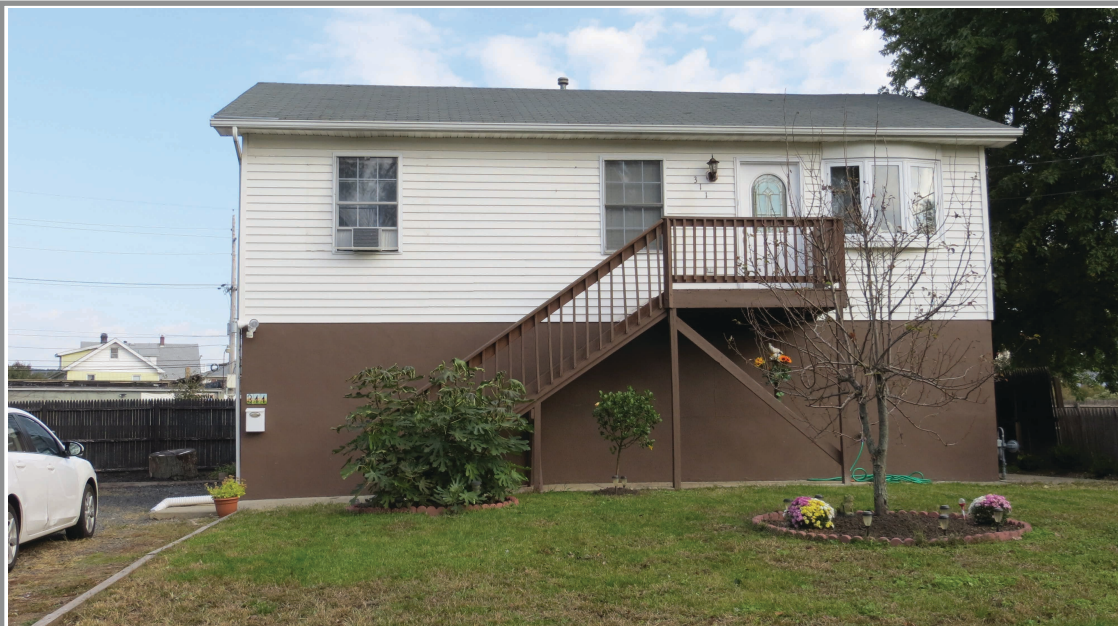
BLOCK 3, LOT 8

Address	311 West Main Street
Acreage	0.38
Acreage in Rehab Area	0.38
Use	2-story frame single-family
Year Built	1997
Habitable Area	662 square feet
Condition	Good
Comments	Well maintained
Code Violations	NA

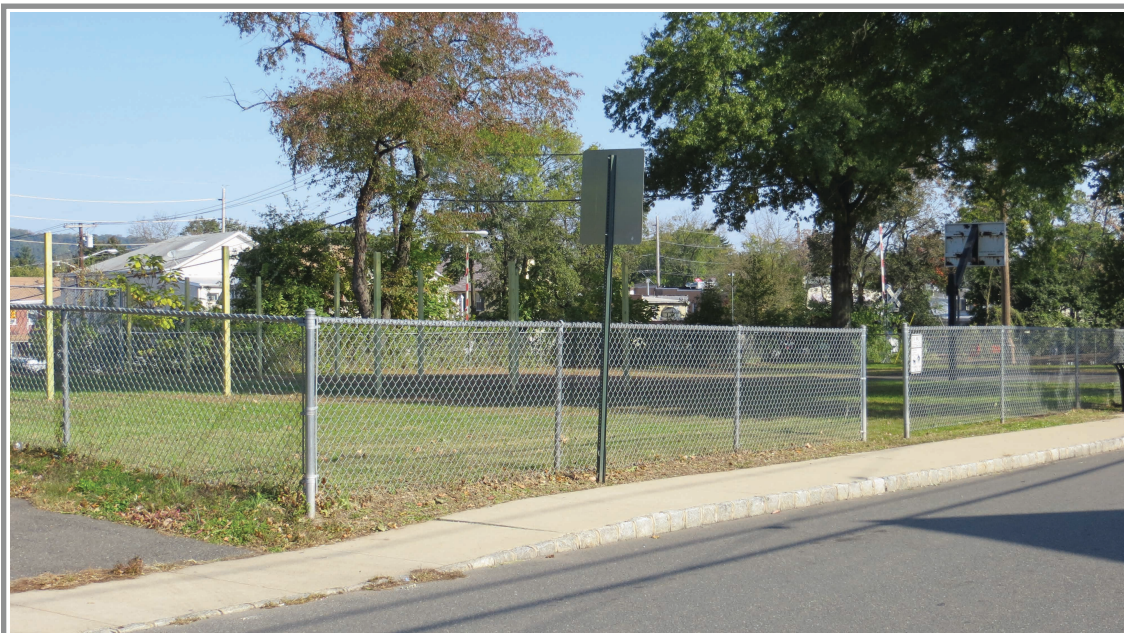
BLOCK 4, LOT 18

Address	No street address
Acreage	0.35
Acreage in Rehab Area	0.35
Use	Public park with basketball hoop
Year Built	NA
Habitable Area	NA
Condition	Good
Comments	Well maintained
Code Violations	NA

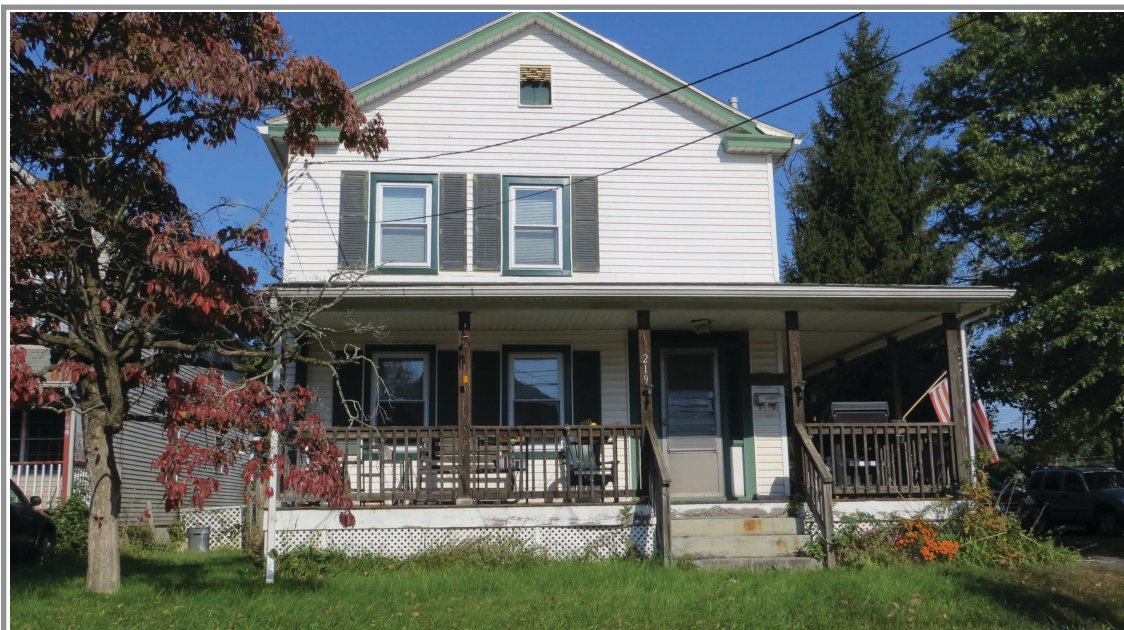
BLOCK 4, LOT 19

Address	219 West Main Street
Acreage	0.22
Acreage in Rehab Area	0.22
Use	2-story frame single-family 1 car detached garage
Year Built	1927
Habitable Area	1,630 square feet
Condition	Fair
Comments	Requires upkeep and maintenance, e.g. overgrown vegetation, paint, secure exterior light fixture, etc.
Code Violations	NA

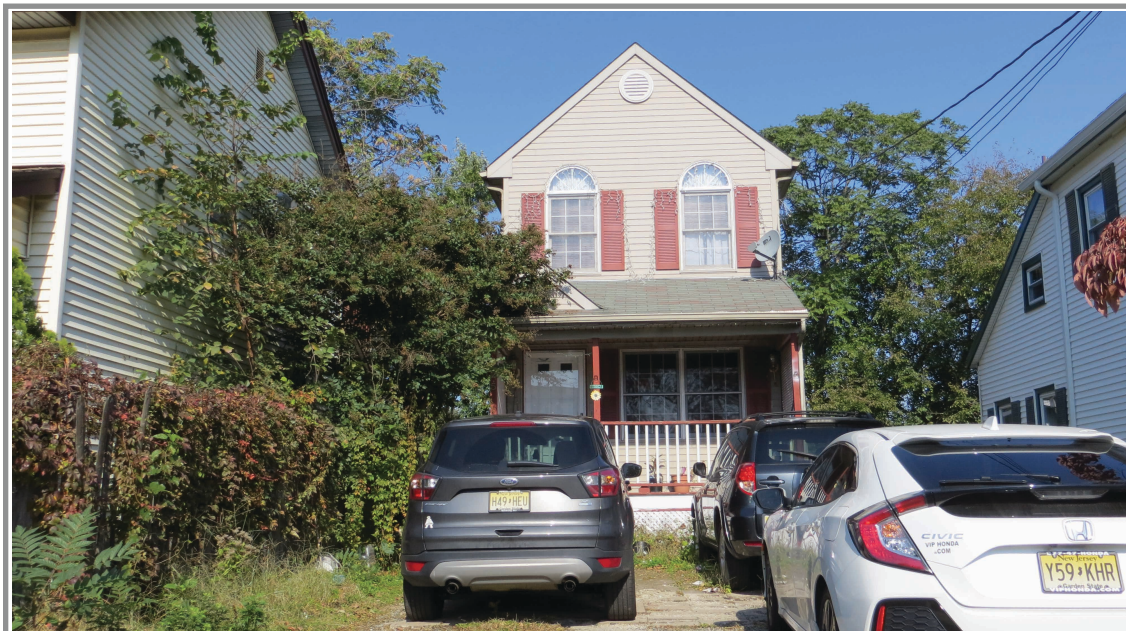
BLOCK 4, LOT 20

Address	225 West Main Street
Acreage	0.07
Acreage in Rehab Area	0.07
Use	2-story frame single-family
Year Built	1958
Habitable Area	1,204 square feet
Condition	Good
Comments	Requires upkeep for overgrown vegetation
Code Violations	3/12/18 <ul style="list-style-type: none">• Statute 17.26.7 Inspections

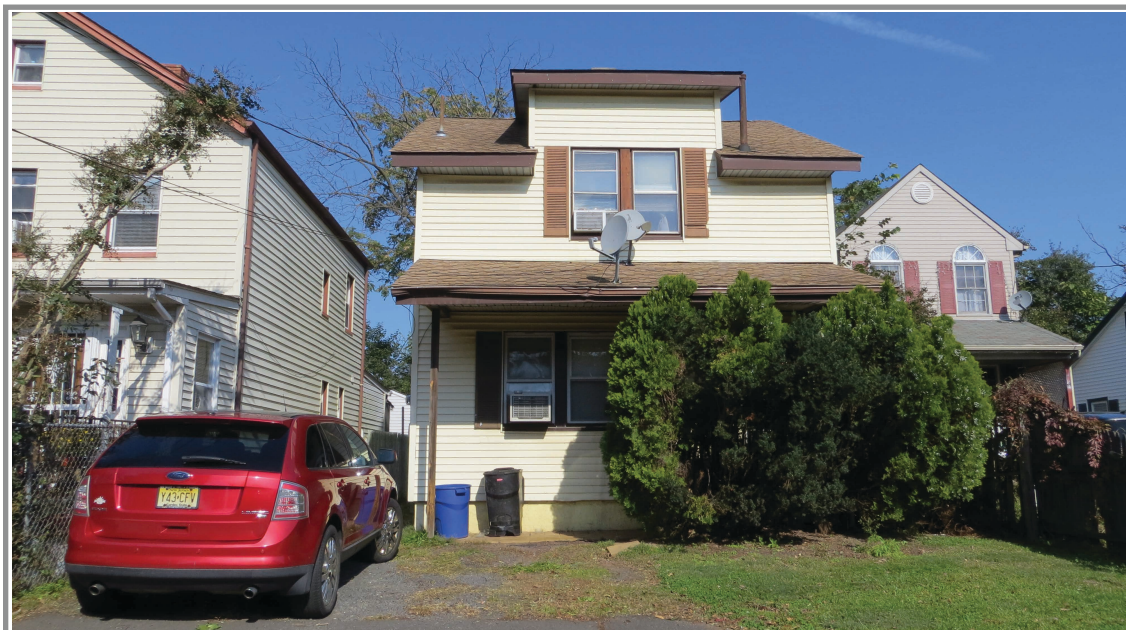
BLOCK 4, LOT 21

Address	225 1/2 West Main Street
Acreage	0.09
Acreage in Rehab Area	0.09
Use	2-story frame single-family 1 car detached garage
Year Built	1924
Habitable Area	1,192 square feet
Condition	Fair
Comments	Requires upkeep for overgrown vegetation in sideyard and maintenance to roof and facade
Code Violations	3/12/18 <ul style="list-style-type: none">• Statute 17-26.7 Inspections

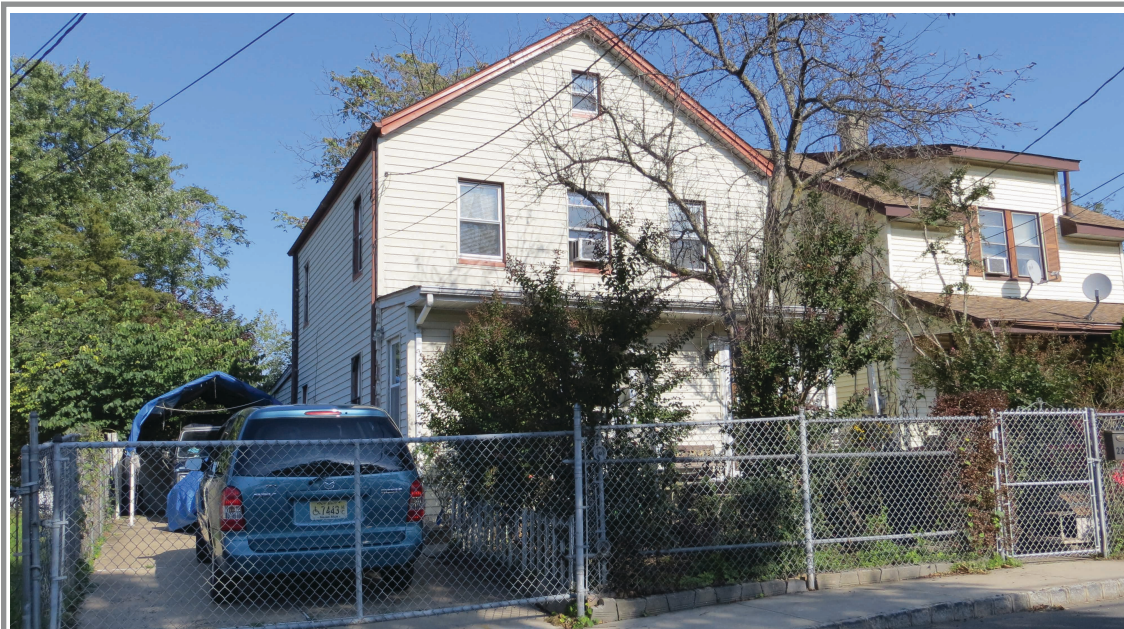
BLOCK 4, LOT 22

Address	227 West Main Street
Acreage	0.13
Acreage in Rehab Area	0.13
Use	2-story frame single-family
Year Built	1900
Habitable Area	1,418 square feet
Condition	Good
Comments	Requires general yard upkeep
Code Violations	NA

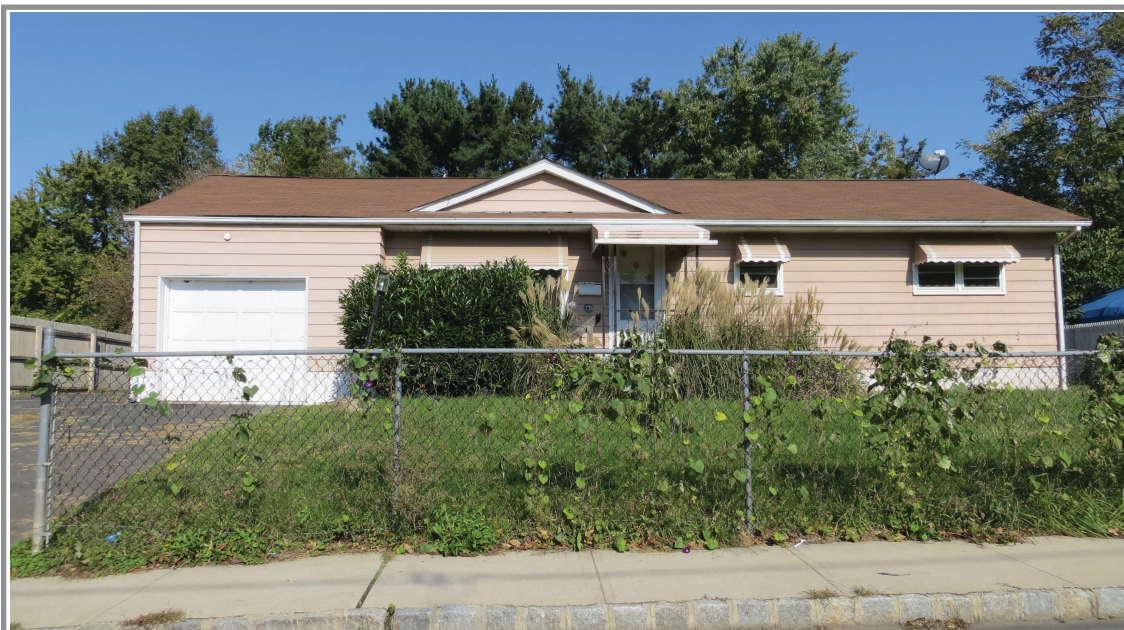
BLOCK 4, LOT 23.01

Address	235 West Main Street
Acreage	0.34
Acreage in Rehab Area	0.34
Use	1-story frame single-family 1 car attached garage
Year Built	1825
Habitable Area	3,257 square feet
Condition	Good
Comments	Requires general yard upkeep
Code Violations	NA

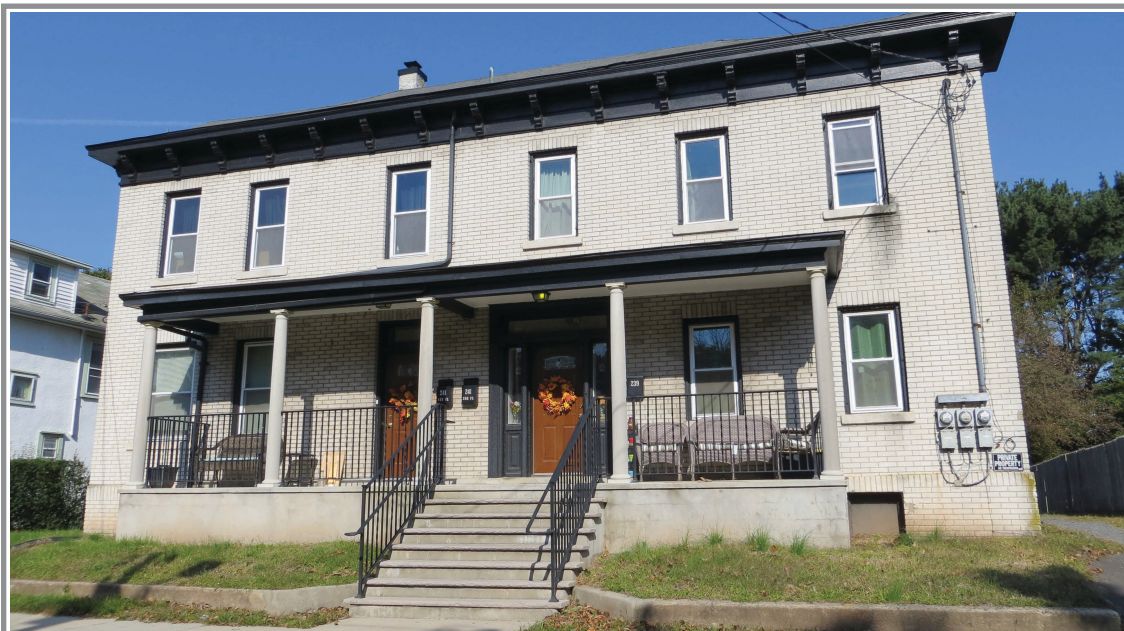
BLOCK 4, LOT 23

Address	239 West Main Street
Acreage	0.26
Acreage in Rehab Area	0.26
Use	2-story brick three-family
Year Built	1962
Habitable Area	1,164 square feet
Condition	Good
Comments	Requires minor upkeep to facade
Code Violations	6/23/18 • Statute 17-14.4 Weeds 3/12/18 • Statute 17-26.7 Inspections

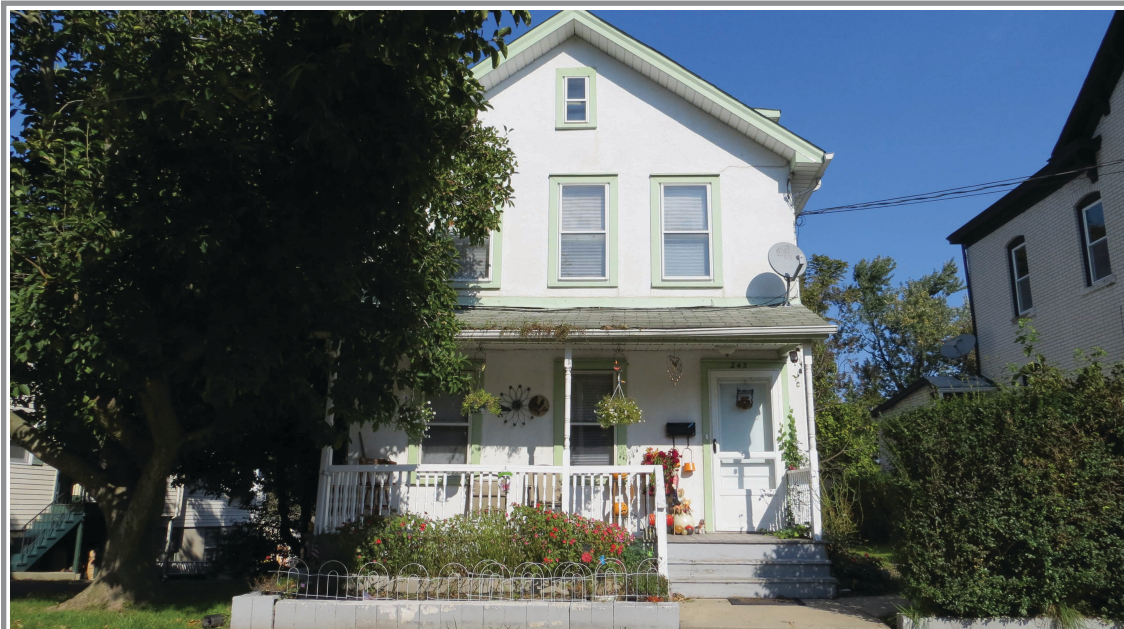
BLOCK 4, LOT 24

Address	245 West Main Street
Acreage	0.26
Acreage in Rehab Area	0.26
Use	2.5-story stucco single-family rear yard structure
Year Built	1809
Habitable Area	1,200 square feet
Condition	Fair
Comments	Requires upkeep and maintenance, e.g. gutters, roof repair and cracking in structure facade
Code Violations	NA

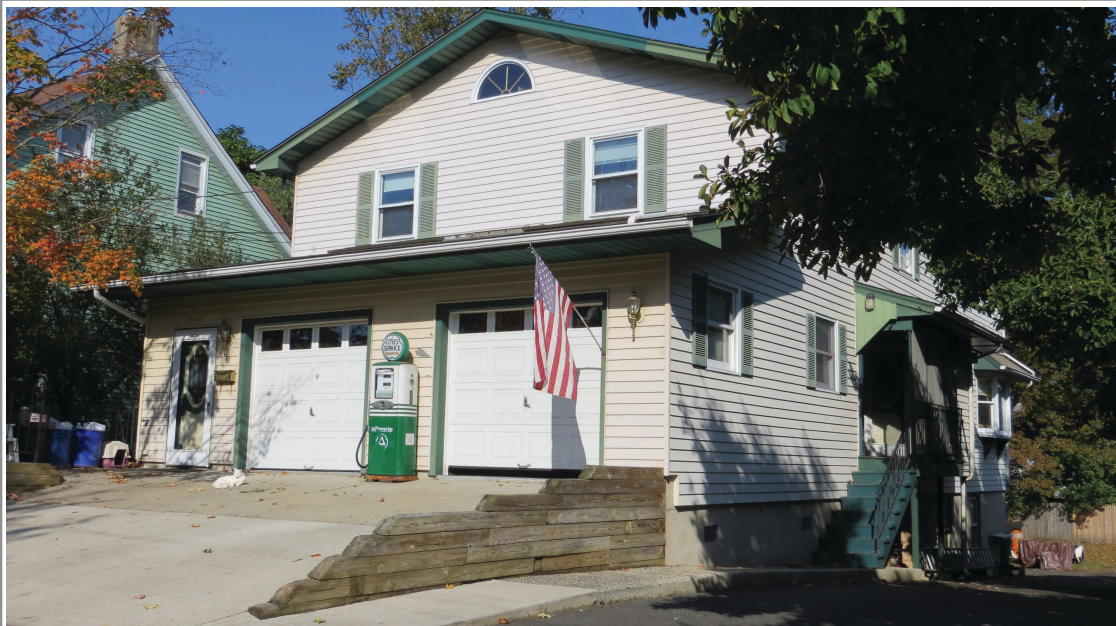
BLOCK 4, LOT 24.01

Address	247 West Main Street
Acreage	0.21
Acreage in Rehab Area	0.21
Use	2-story frame single-family 2 car attached garage and rear yard structure
Year Built	1960
Habitable Area	2,446 square feet
Condition	Good
Comments	Well maintained
Code Violations	NA

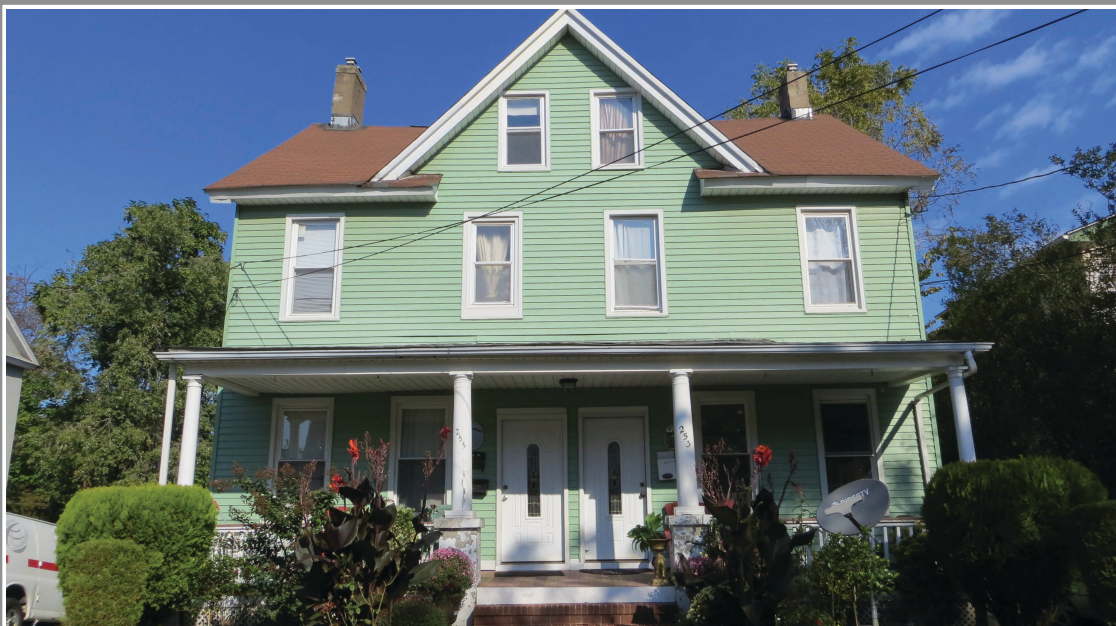
BLOCK 4, LOT 25

Address	253-255 West Main Street
Acreage	0.19
Acreage in Rehab Area	0.19
Use	2.5-story frame two-family
Year Built	1900
Habitable Area	2,545 square feet
Condition	Fair
Comments	Requires upkeep and maintenance e.g. paint, window screen repairs, and roof structure inspection
Code Violations	3/4/18 <ul style="list-style-type: none"> Statute 5:10-19.2a 1-7 Multiple dwellings

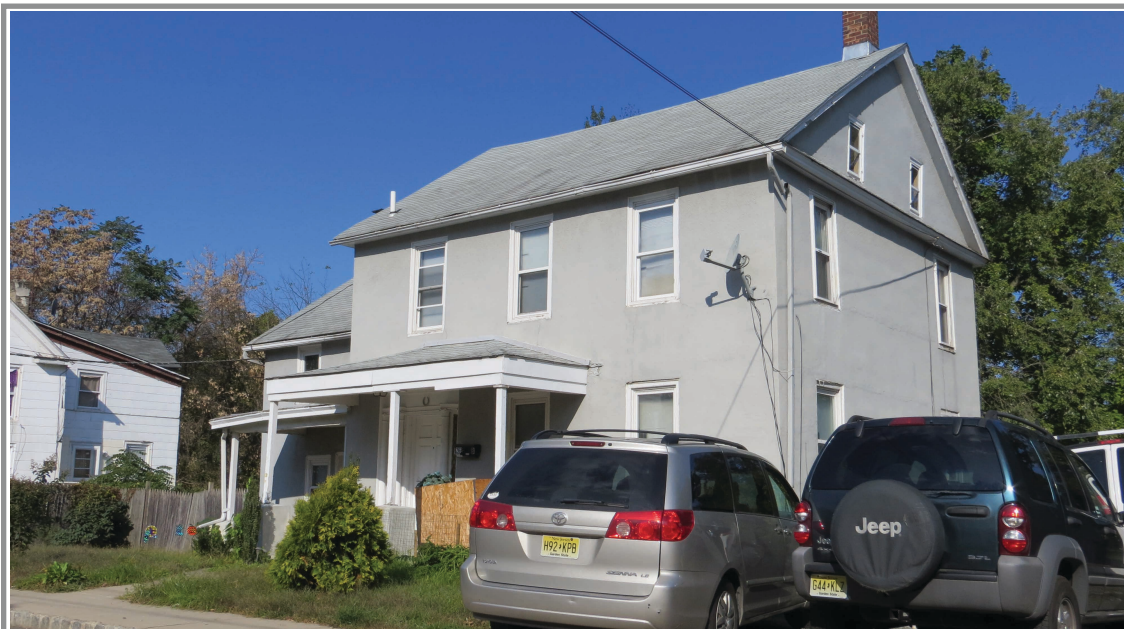
BLOCK 4, LOT 26

Address	261 West Main Street
Acreage	0.35
Acreage in Rehab Area	0.35
Use	2.5-story stucco three-family
Year Built	1895
Habitable Area	2,028 square feet
Condition	Fair
Comments	Requires upkeep and maintenance of fence, roof structure and overgrown vegetation
Code Violations	3/12/18 <ul style="list-style-type: none"> • Statute 5:10-1.10e Bureau inspections
	6/14/17 <ul style="list-style-type: none"> • Parking vehicles on lawns prohibited

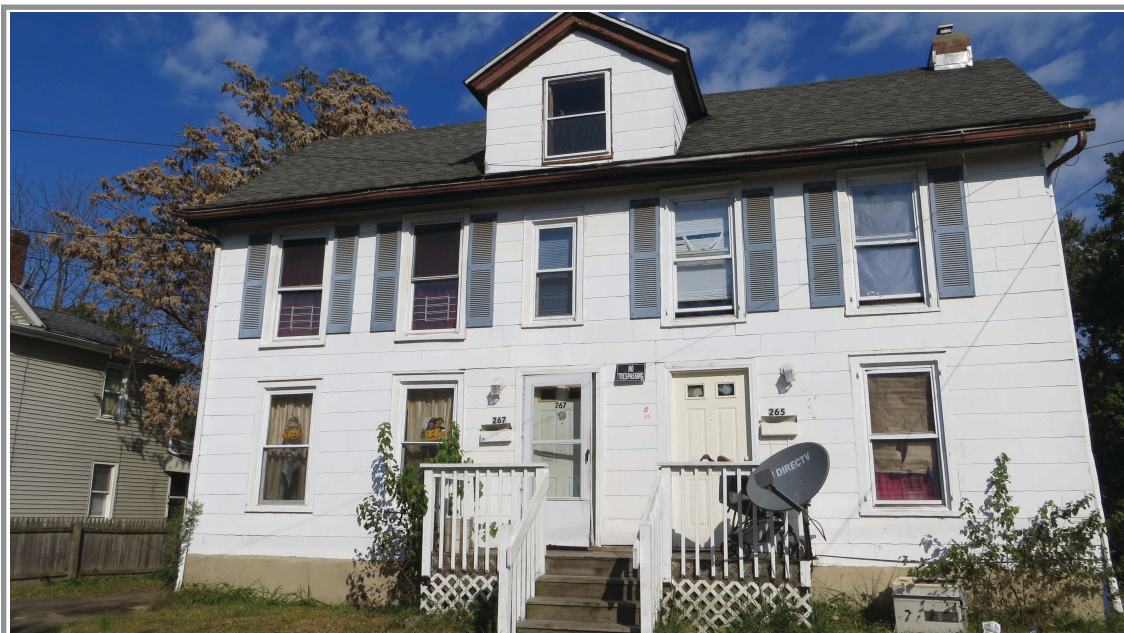
BLOCK 4, LOT 27

Address	265-267 West Main Street
Acreage	0.28
Acreage in Rehab Area	0.28
Use	2.5-story frame two-family
Year Built	1917
Habitable Area	2,180
Condition	Poor
Comments	Requires upkeep and maintenance, e.g. litter, debris, overgrown vegetation gutters, windows, roof
Code Violations	8/22/17 <ul style="list-style-type: none"> • Statute 17-14.9 Motor vehicles
	7/3/17 <ul style="list-style-type: none"> • Sanitation - furniture /tv/garbage on property sanitation; parking storage of inoperable vehicle
	4/1/17 <ul style="list-style-type: none"> • Accumulation of rubbish or garbage; containers; responsibility - remove trash cans from public eye

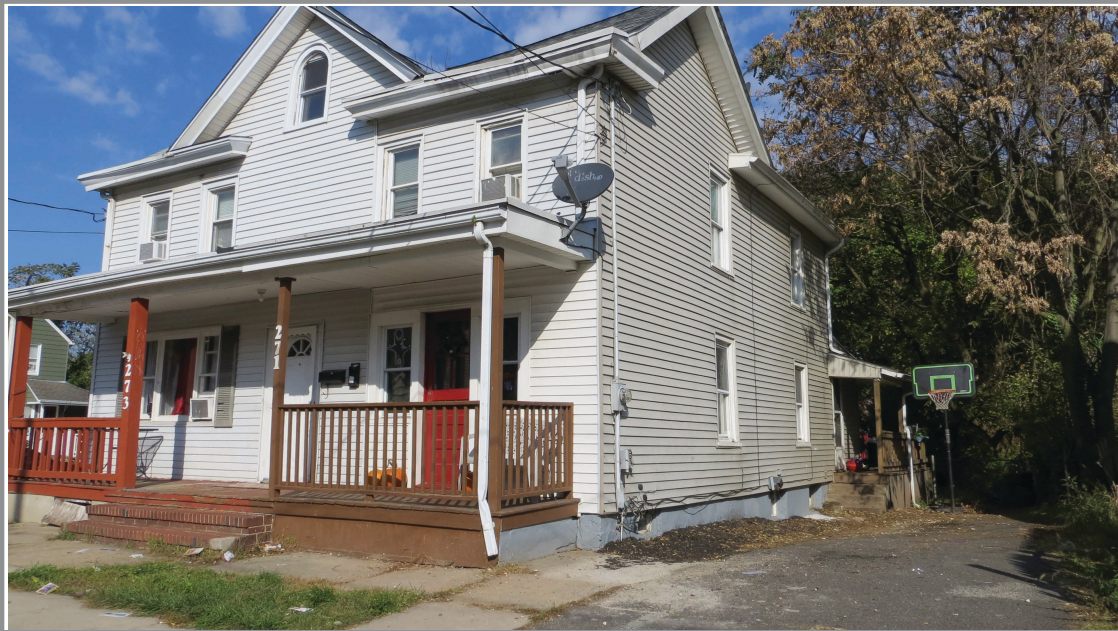
BLOCK 4, LOT 28

Address	271 West Main Street
Acreage	0.14
Acreage in Rehab Area	0.14
Use	2-story frame single-family (attached to building on lot 28.01)
Year Built	1917
Habitable Area	1,100 square feet
Condition	Fair
Comments	Requires general upkeep, e.g. vegetation growing in gutter/downspout and litter

3/12/18 Statute 5:10-8.1a Basements, cellars and crawl spaces; Statute 17-22.12 Single-and Multi-Station smoke alarms; Statute 5:10-19.2a 8-11 Multiple dwellings; Statute 5:10-13.1d Electrical service; Statute 5:10-13.1a Electrical service
 11/22/17 Statute 17-20.1 Accumulation of rubbish, trash and debris
 9/12/17 Statute 17-14 Exterior property; Statute 17-14.9 Motor vehicles

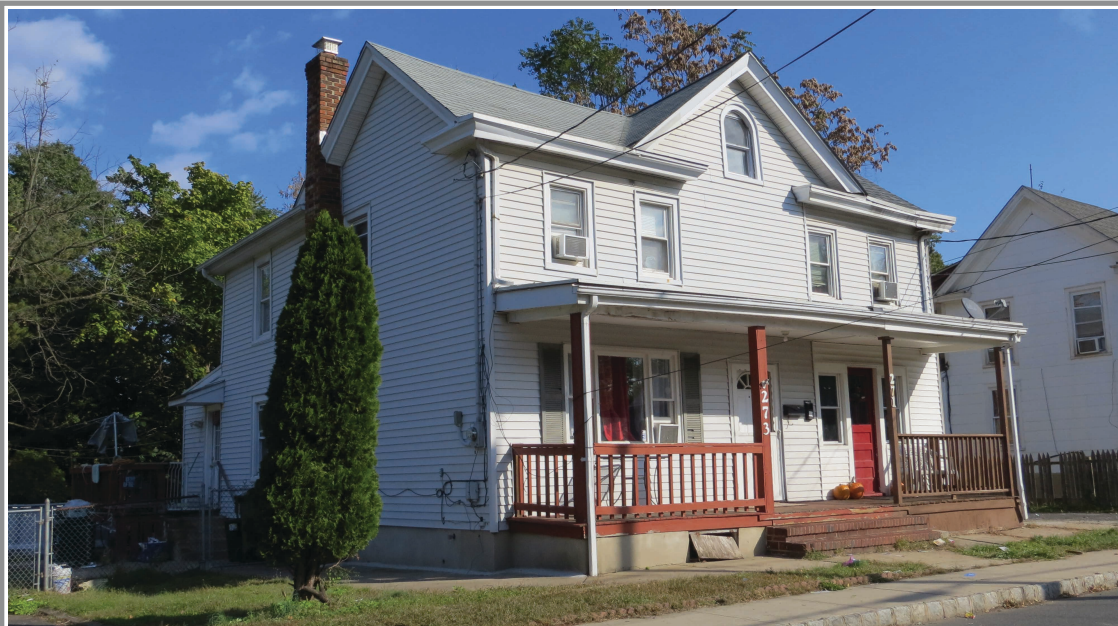
BLOCK 4, LOT 28.01

Address	273 West Main Street
Acreage	0.22
Acreage in Rehab Area	0.22
Use	2-story frame single-family (attached to building on lot 28)
Year Built	1917
Habitable Area	1,100 square feet
Condition	Poor
Comments	Requires general upkeep and maintenance, e.g. window screens, litter, crawl space door, etc.

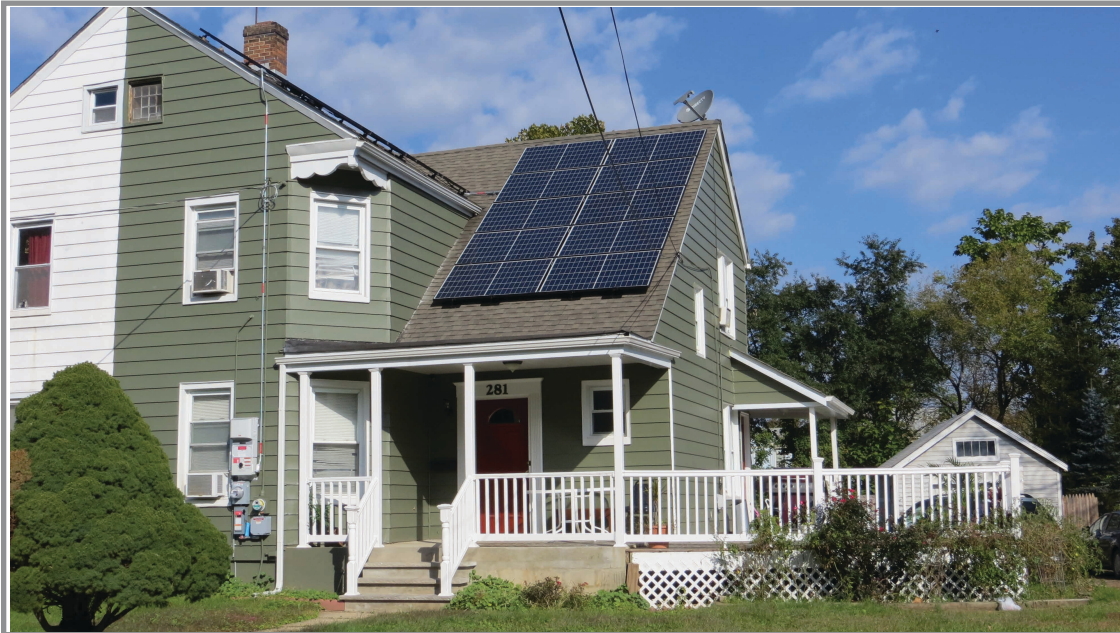
BLOCK 4, LOT 29

Address	281 West Main Street
Acreage	0.25
Acreage in Rehab Area	0.25
Use	2.5-story frame single-family (attached to building on lot 29.01) 1 car detached garage
Year Built	1890
Habitable Area	1,314 square feet
Condition	Good
Comments	Well maintained
Code Violations	2/3/18 <ul style="list-style-type: none"> • Statute 17-22.12 Single-And Multi-Station smoke alarms; • Statute 17-16.7 Roofs and Drainage; • Statute 17-22.2 Means of Egress General

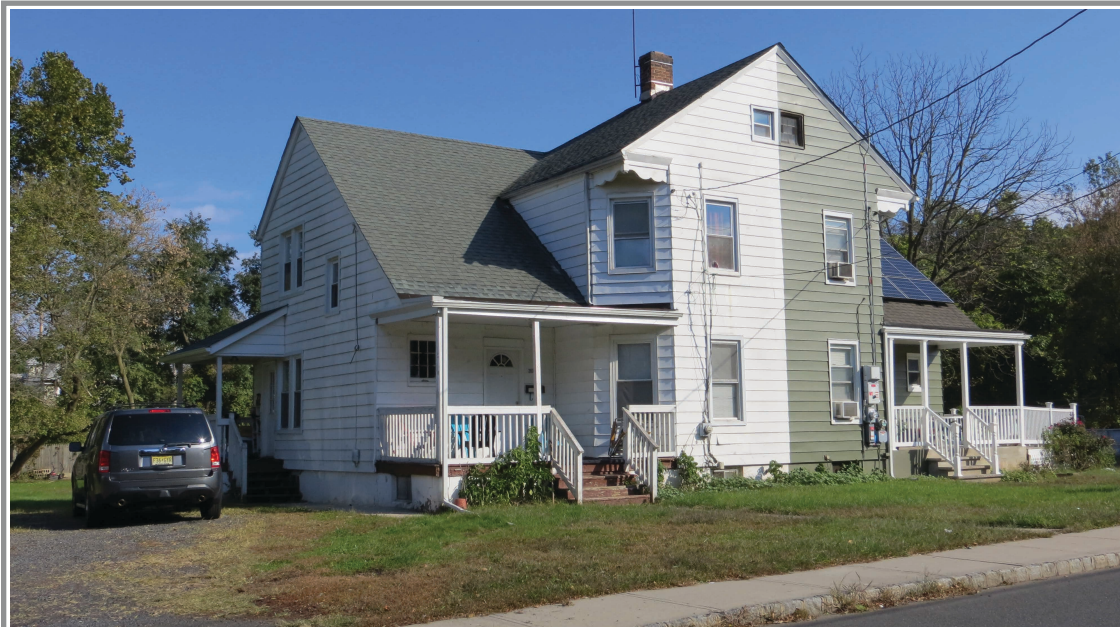
BLOCK 4, LOT 29.01

Address	283 West Main Street
Acreage	0.23
Acreage in Rehab Area	0.23
Use	2.5-story frame single-family (attached to building on lot 29)
Year Built	1890
Habitable Area	1,193 square feet
Condition	Fair
Comments	Requires general upkeep and maintenance, e.g. paint, window screens, weeds
Code Violations	NA

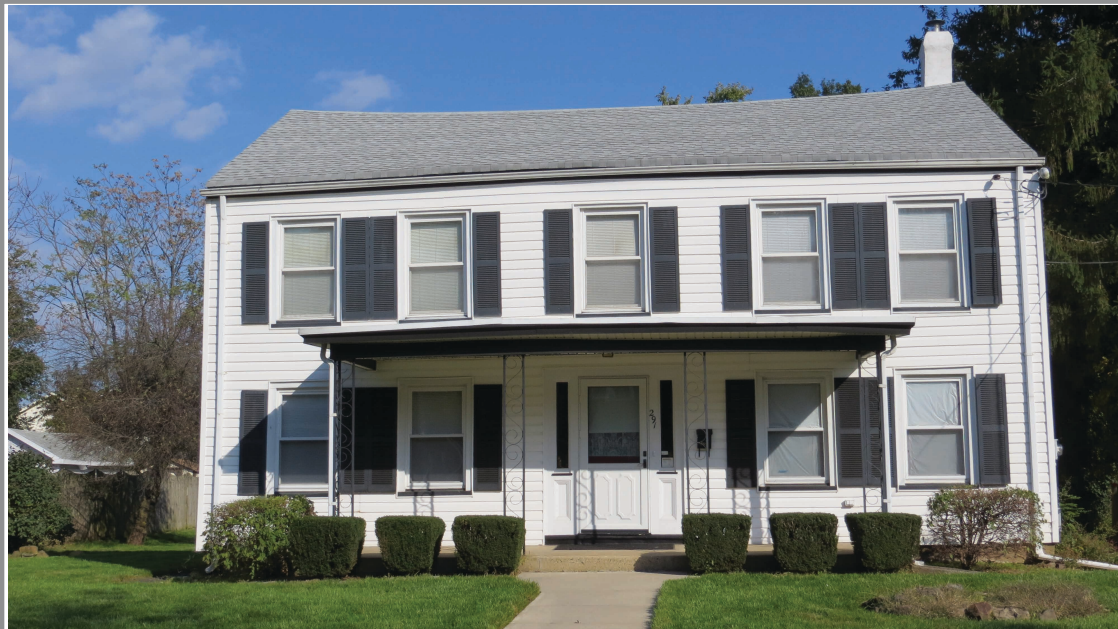
BLOCK 4, LOT 30

Address	291 West Main Street
Acreage	0.26
Acreage in Rehab Area	0.26
Use	2-story frame single-family
Year Built	1900
Habitable Area	2,242 square feet
Condition	Fair
Comments	Well maintained; structure requires inspection, e.g. warped roof line
Code Violations	NA

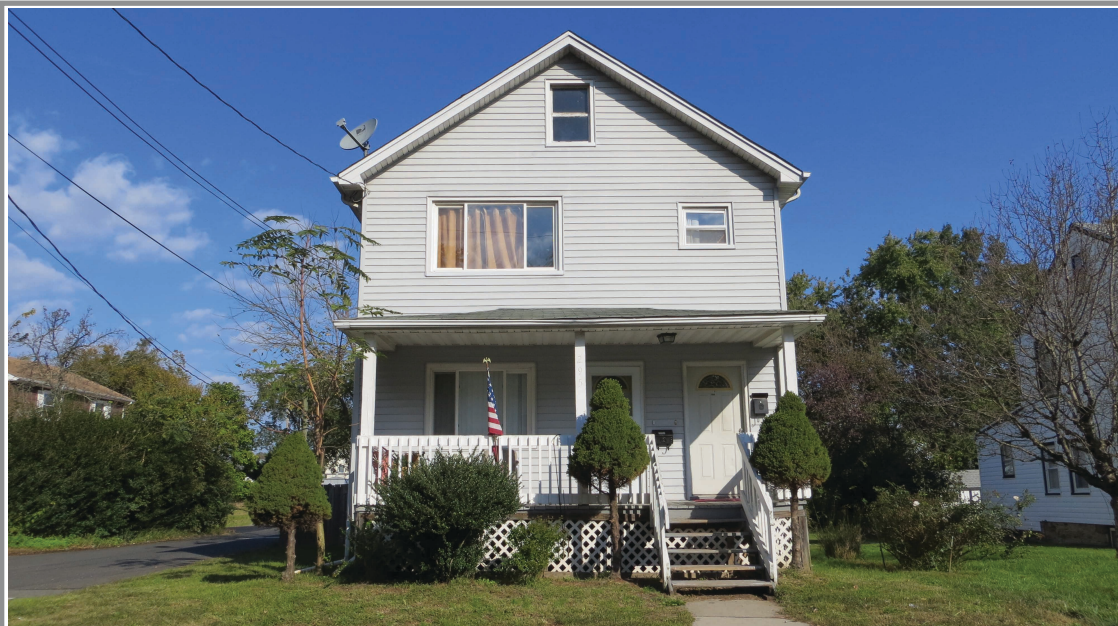
BLOCK 4, LOT 31

Address	295 West Main Street
Acreage	0.11
Acreage in Rehab Area	0.11
Use	2.5-story frame two-family 1 car detached garage
Year Built	1900
Habitable Area	1,458 square feet
Condition	Fair
Comments	Garage requires repair
Code Violations	9/16/17 • Statute 17-14 Exterior property
	9/12/17 • Statute PR 3-16.2 Parking, storage of inoperable vehicles
	9/2/17 • Statute 17-14 Exterior property

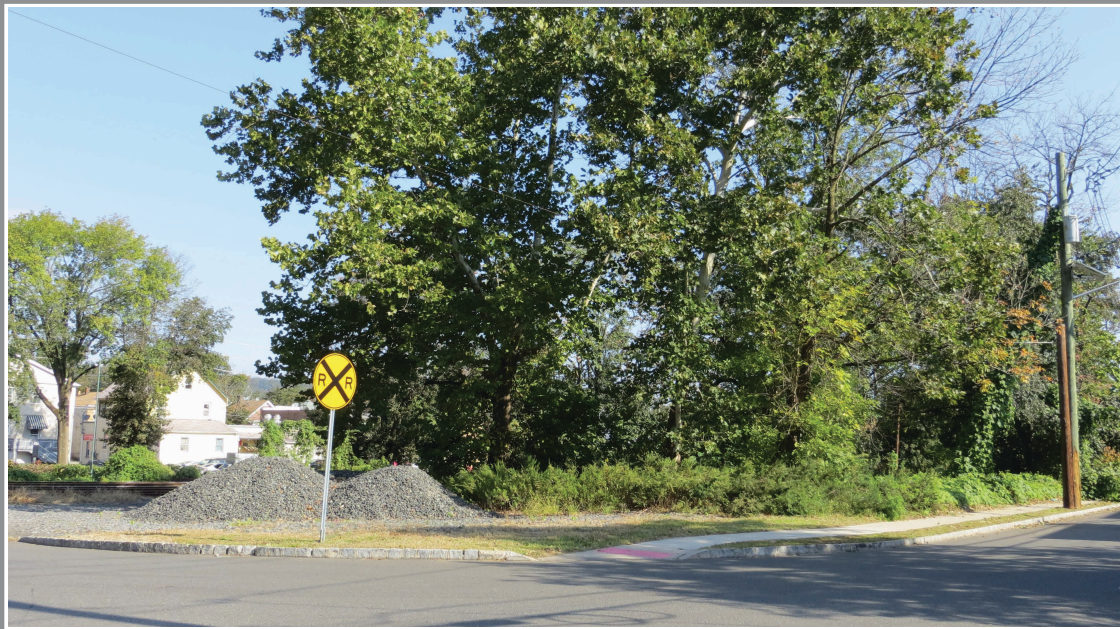
BLOCK 5, LOT 29

Address	No street address
Acreage	0.12
Acreage in Rehab Area	0.12
Use	Wooded area
Year Built	NA
Habitable Area	NA
Condition	Good
Comments	NA
Code Violations	NA
